**Blossom Hill Station
Arborist Report**

Project #4361-01

H. T. Harvey & Associates

February 19, 2020

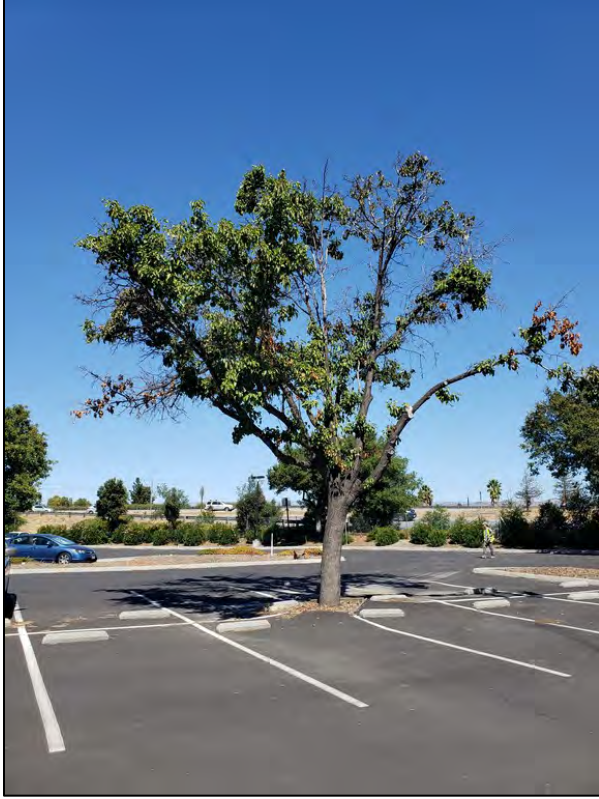
Eighty (80) trees (58%), including 30 of the 54 Chinese pistache trees, were in good condition, 45 trees (33%) were in fair condition, and 13 trees (9%) were in poor condition (Table 2). Health and vigor scores and condition ratings of each tree are presented in Appendix C. Most trees in poor and fair condition were evergreen pear (*Pyrus kawakamii*) and exhibited canopy dieback such as shown in Photo 2 in Appendix D.

Photo 2. Tree #626, Evergreen pear (*Pyrus kawakamii*)

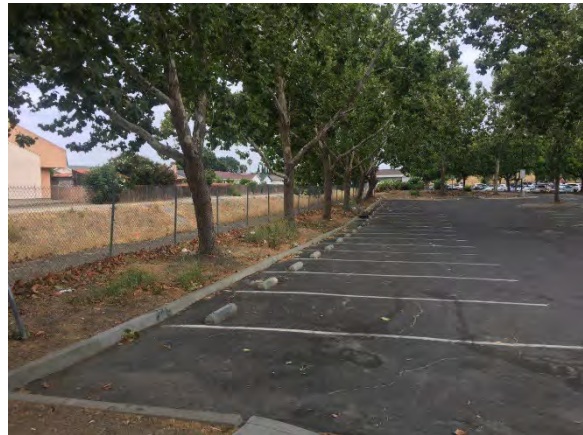
Photo 1. Ornamental London plane trees lining the parking lot on the project site, with channel slopes of Canoas Creek (outside the project site) in the background.

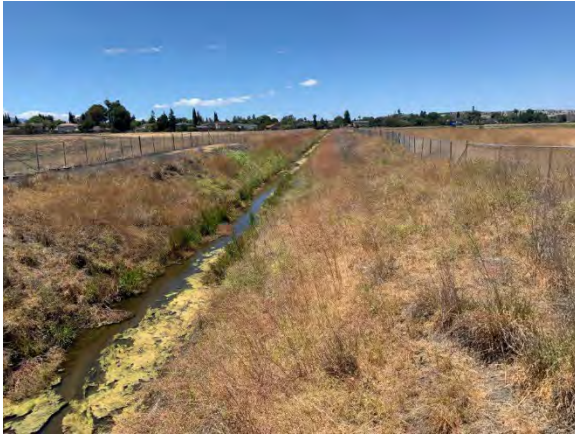
The northernmost approximately 640 feet of the proposed trail alignment passes along the edge of a fallowed agricultural field and consists of the grain, row-crop, hay and pasture, disked/short-term fallowed VHP land cover type (Photo 2). The proposed trail would be constructed in between the edge of the existing field and the top of bank of Canoas Creek. The vegetation in this portion of the alignment is dominated by a dense cover of non-native annual grasses, such as bromes (*Bromus* spp.) and invasive forbs such as black mustard (*Brassica nigra*) and Italian thistle (Photo 2).

Photo 2. The proposed trail alignment at the north end of the site follows the edge of a fallowed field (view to the north).

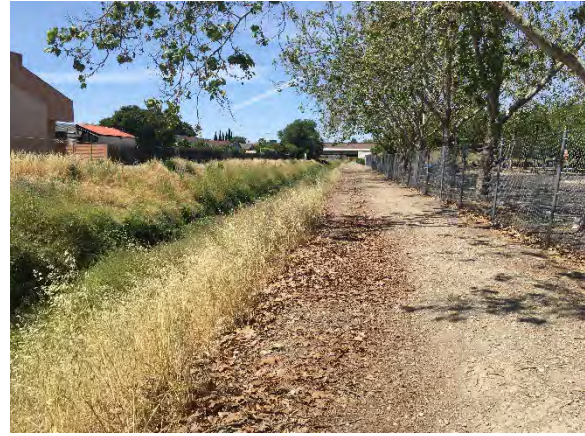
Photo 3. The Valley Water access road and Canoas Creek channel adjacent to the project site (looking downstream).

The Canoas Creek corridor adjacent to the project site (i.e., outside the project's impact footprint) is an engineered, trapezoidal stormwater and flood-control channel owned and operated by Valley Water (Photos 3–5). Water was present in the channel during the August 2019 and June 2021 field surveys, indicating that flow in the channel is perennial. The channel alignment is straight along the length of the project site. The bed of the channel is approximately 4 feet wide and lacked any continuous wetland vegetation within the channel bed at the time of the August 2019 and June 2021 surveys. Due to the straightened nature of channel adjacent to the project site, flows in this stretch following winter storm events are expected to be high-velocity and scouring, prohibiting the establishment of wetland vegetation. In addition, Valley Water maintains the channel by periodically removing accumulated sediment and vegetation to encourage the stormwater conveyance function of the channel when necessary. Vegetation cover on the banks of the channel is herbaceous, with the dominant species being non-native grasses and forbs such as wild oats (*Avena* spp.), Harding grass (*Phalaris aquatica*), and Italian thistle (*Carduus pycnocephala*). This vegetation is periodically mown by Valley Water along most of the alignment. An existing gravel road that currently serves as a Valley Water maintenance access road extends northward from Blossom Hill Road along approximately 1,390 feet of the project site on the eastern side of Canoas Creek (Photos 3–5).

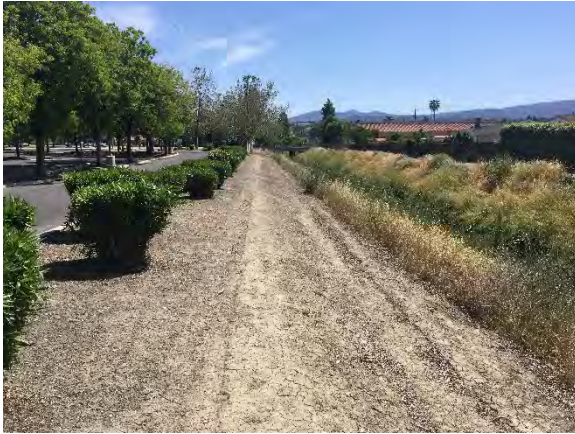
Photo 4. The Valley Water access road and Canoas Creek channel adjacent to the project site (looking upstream).

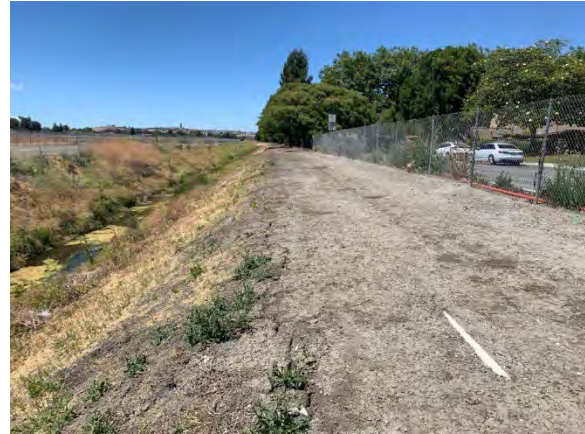
Photo 5. The Valley Water access road and Canoas Creek channel to the north of State Route 85 (view to the north).

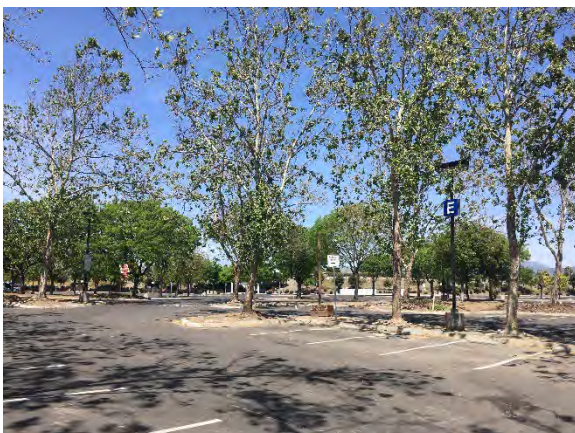
General Wildlife Use. Due to the scarcity of vegetation, the project site provides low-quality habitat for wildlife species (Photos 6 and 7). The wildlife most often associated with these areas are those that are tolerant of periodic human disturbances, including introduced species such as the nonnative European starling (*Sturnus vulgaris*), rock pigeon (*Columba livia*), house mouse (*Mus musculus*), and Norway rat (*Rattus norvegicus*). Several common, urban-adapted native species also use this habitat, including the American crow (*Corvus brachyrhynchos*), house finch (*Haemorhous mexicanus*), and raccoon (*Procyon lotor*). Few birds are likely to nest on the site due to the sparseness of vegetation, but common species such as the lesser goldfinch (*Spinus psaltria*), Anna's hummingbird (*Calypte anna*), and bushtit (*Psaltriparus minimus*) may nest in the trees present. Burrows of California ground squirrels (*Otospermophilus beecheyi*) are present along the western edge of the site within the project's impact area. Birds such as the black phoebe (*Sayornis nigricans*) and cliff swallow (*Petrochelidon pyrrhonota*) are expected to nest on the Blossom Hill Road and SR 85 bridges over Canoas Creek immediately adjacent to the site; however, no large colonies of swallows were observed on these bridges during the May 2020 survey.

Photo 6. The parking areas on the project site are planted with trees that provide limited habitat for wildlife.

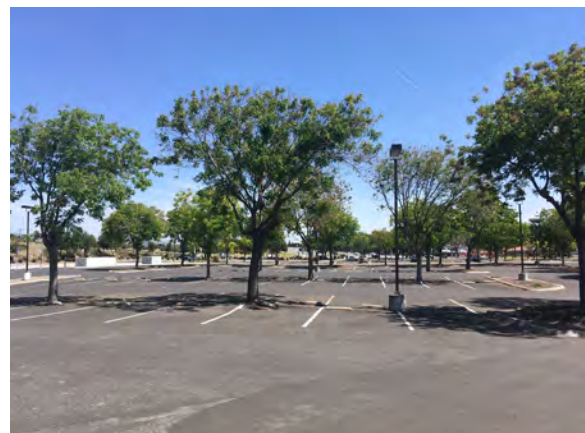
Photo 7. The parking areas on the project site are planted with trees that provide limited habitat for wildlife.

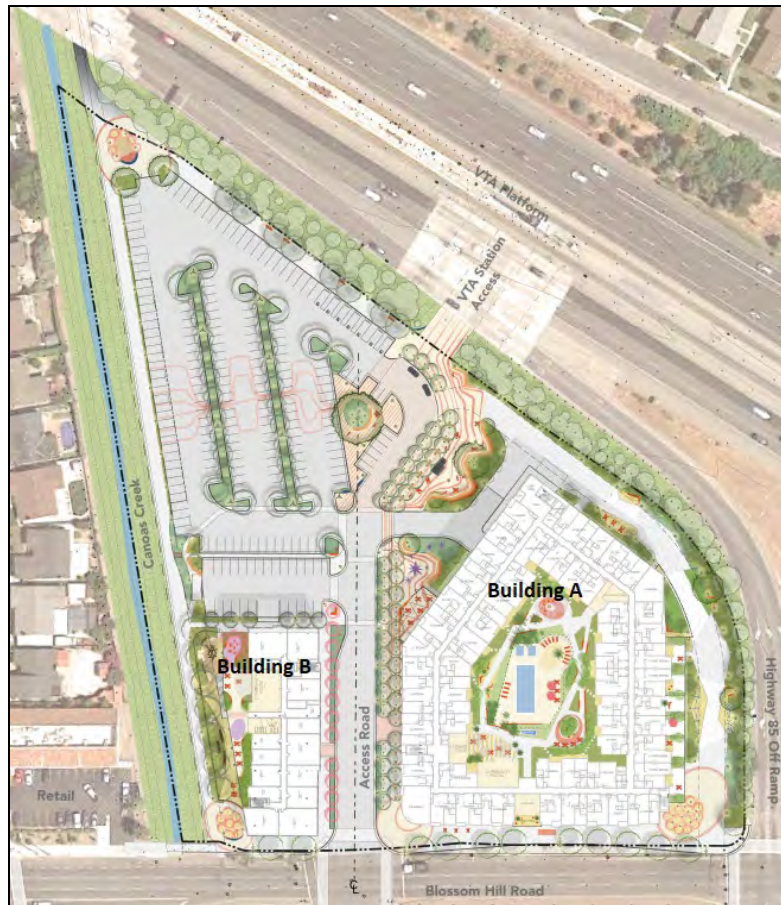
Figure 4. Project site plan showing the extent of proposed landscape vegetation relative to building facades.

the west façade of Building B faces Canoas Creek, which is expected to support higher numbers of birds compared to other areas of the site. Because vegetation is planted immediately adjacent to the building's west facade, birds moving along the creek may be attracted to this vegetation, where they would be more likely to collide with glazing on the west façade. In addition, Building A includes a vegetated courtyard on the Level 3 podium, which is surrounded on all sides by facades (Figure 4). Birds may be attracted to the vegetation within the courtyard, and potentially collide with glazing on the surrounding facades when attempting to exit the courtyard.
