**Wrigley Creek Improvement Project
Milpitas, California
Year 5 (2015) Monitoring Report**

Project #2995-04

September 2015

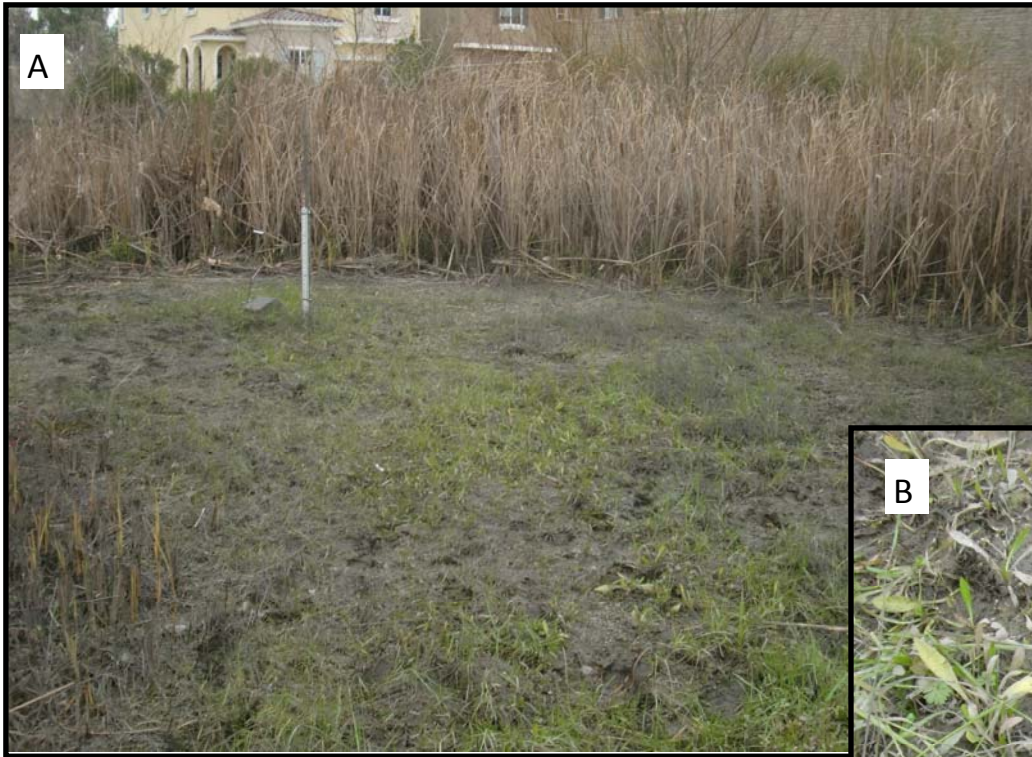
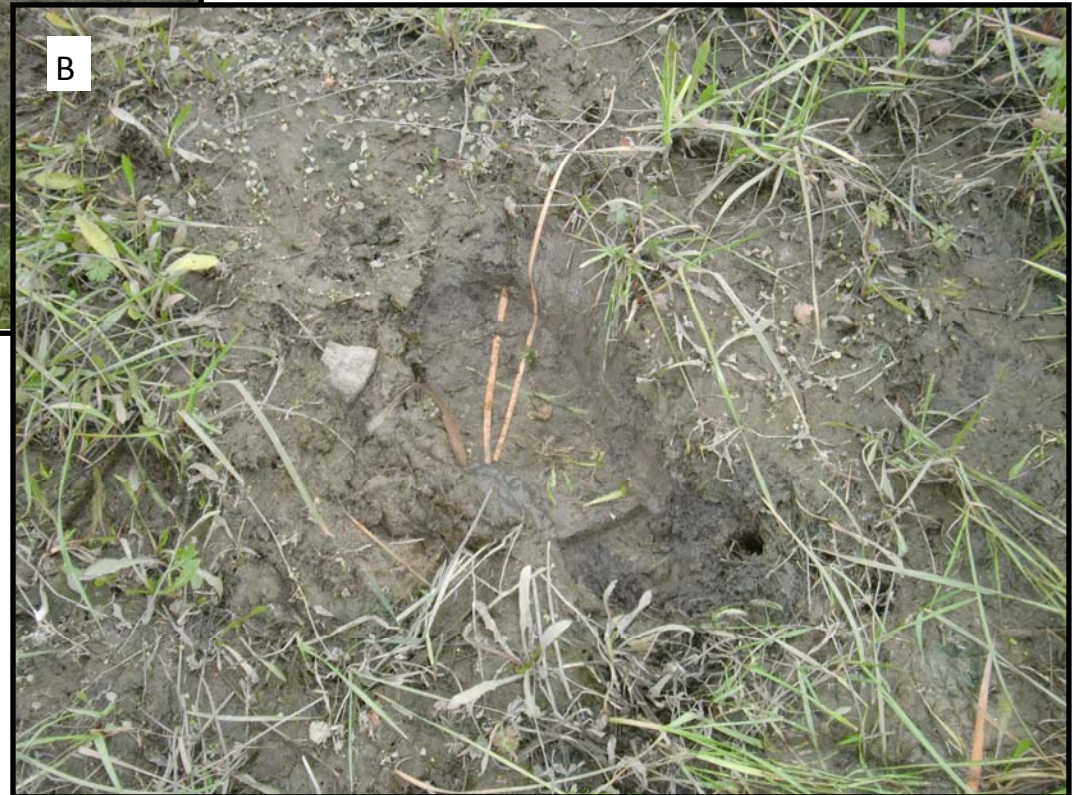
Throughout the wet season, there were approximately 59 days (discontinuous) during which the north gage site was inundated (**Figure 4**). The longest continuous period of inundation was about 24 days, from December 11, 2014 to January 3, 2015. The stage record and field observations show that between November 29, 2014, when storms inundated the site, and January 8, 2015, when moist soils were observed in the field, soils near the gage were either inundated or saturated at a depth of approximately 2 inches, a period of continuous inundation/saturation lasting 40 days. **Figure 5** shows site photos from the January 8 field visit.

Figure 5. January 8, 2015 north gage field photographs. Wrigley Creek Mitigation Performance Monitoring, Santa Clara County, California . On the day these photos were taken, saturated soils were confirmed at the surface at both the north and south gages. A) North gage on January 8, 2015. B) Soils at the north gage on January 8, 2015.

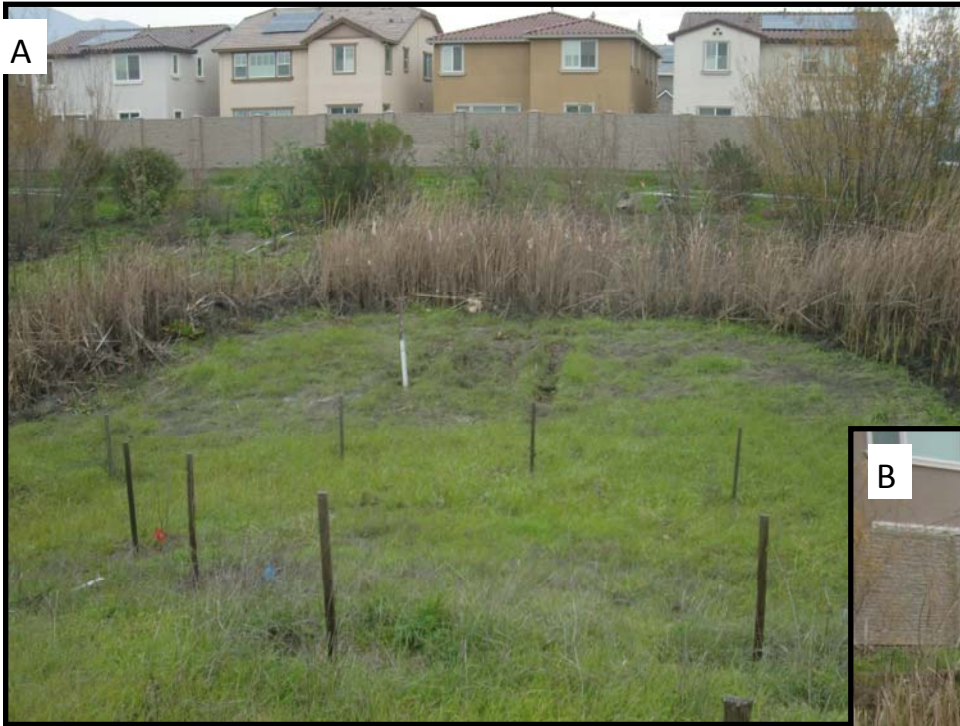
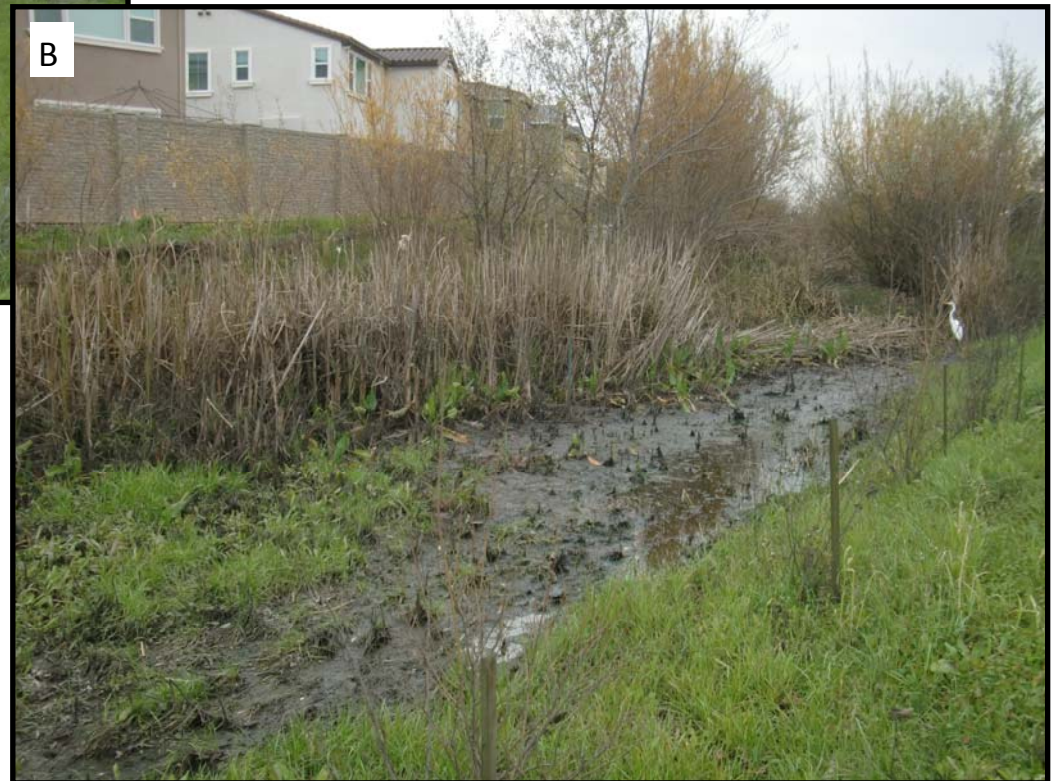
The south gage is located on a section of floodplain that ponds during and after storm events, therefore this site is inundated for a longer duration. According to the stage record (**Figure 4**) there were approximately 78 (discontinuous) during which the south gage site was inundated. The longest period of continuous ponding/inundation lasted 32 days, from November 29, 2014 to January 3, 2015. As at the north gage site, the stage record and field observations show that between November 29, 2014, when storms inundated the site, and January 8, 2015, on which moist soils were observed in the field, soils near the gage were either inundated or saturated at a depth of approximately 2 inches, a period of continuous inundation/saturation lasting 40 days. **Figure 6** shows site photos from the January 8 field visit.

Figure 6. January 8, 2015 south gage field photographs. Wrigley Creek Mitigation Performance Monitoring, Santa Clara County, California . On the day these photos were taken, saturated soils were confirmed at the surface at both the north and south gages. A) South gage on January 8, 2015. B) The channel about 50 feet upstream of the south gage, January 8, 2015.

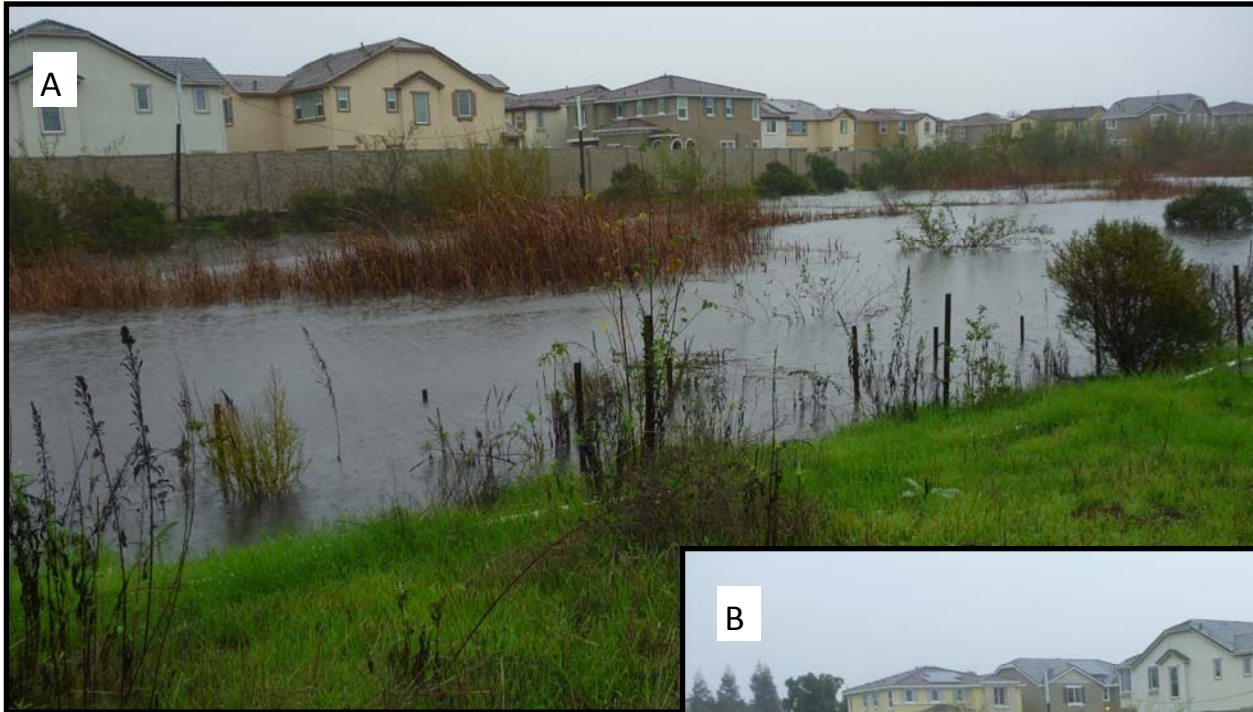
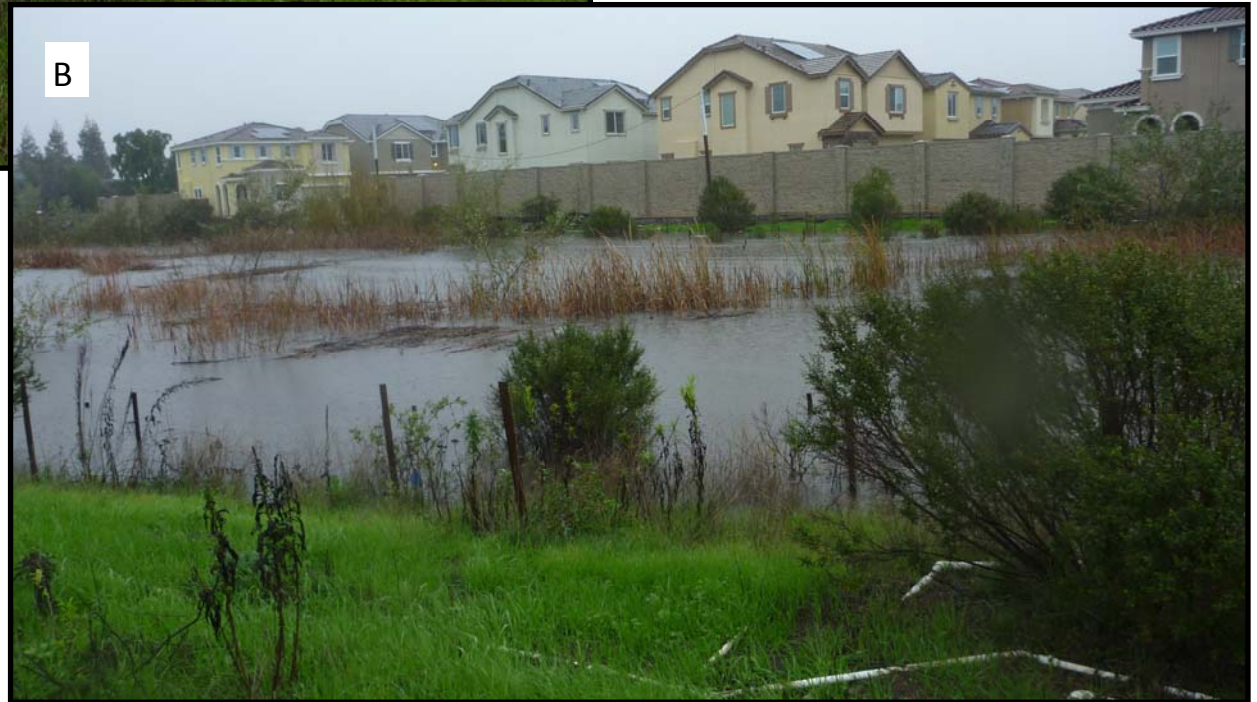
Figure 7.

vegetation was inundated under several feet of water at the time of the visit (**Figure 7**). Discharge measurements were impossible to take with a wading instrument, and difficult to estimate due to turbulent backwater effects. It is encouraging that after an event of this magnitude, no damage was observed following recession of the floodwaters. Due to the dry year and the flashy nature of the site, Balance had few other opportunities to observe flow on the floodplain, and therefore we were not able to measure flow during WY15.

December 11, 2014 storm flow field photographs. Wrigley Creek Mitigation Performance Monitoring, Santa Clara County, California . On the day these photos were taken, high flows inundated both staff plates and most vegetation. The tops of the cattail indicate the location of the channel. A) Looking upstream. B) Looking downstream.

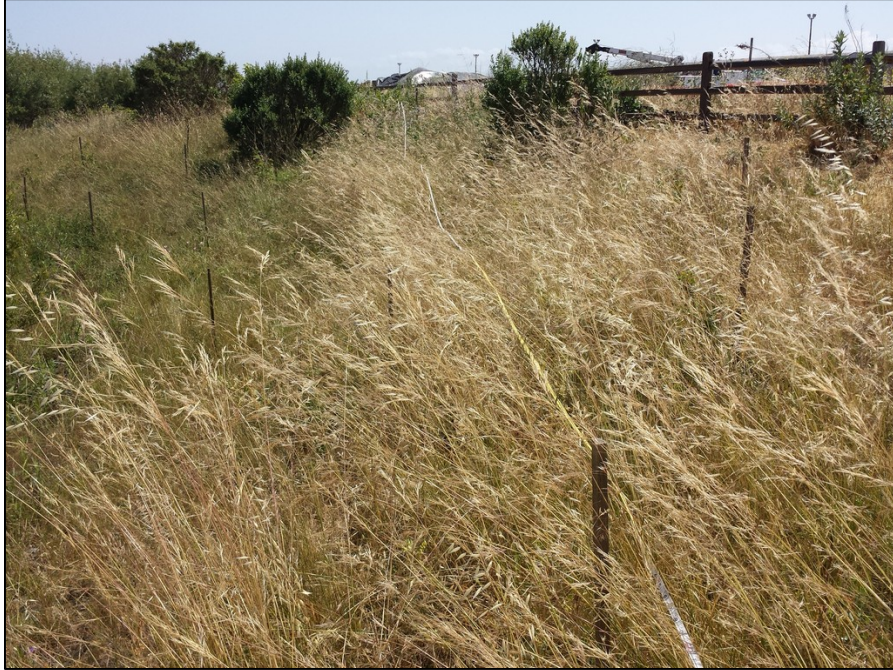
Photo 21. Dense patch of purple needlegrass on the western creek bank slope (May 2015)

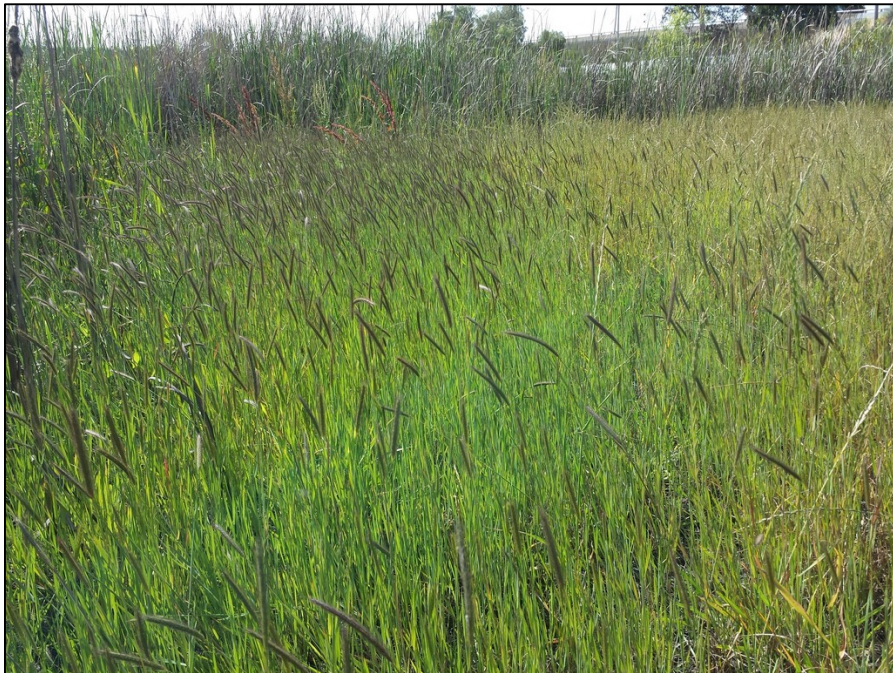
Photo 22. Dense patch of meadow barley on the floodplain (May 2015)

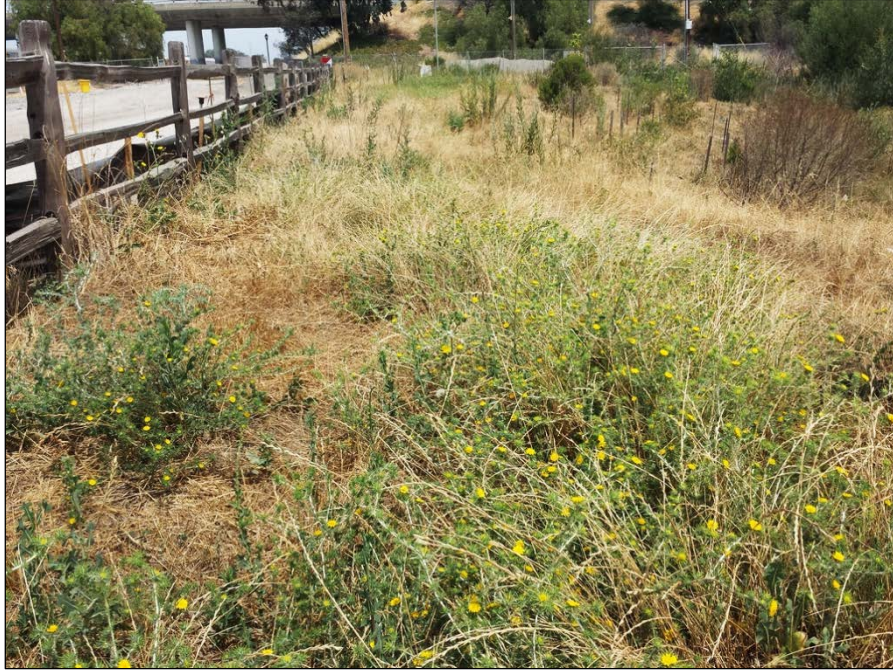
Photo 23. Flowering Congdon's tarplant in the Congdon's Tarplant Mitigation Area (July 2015)

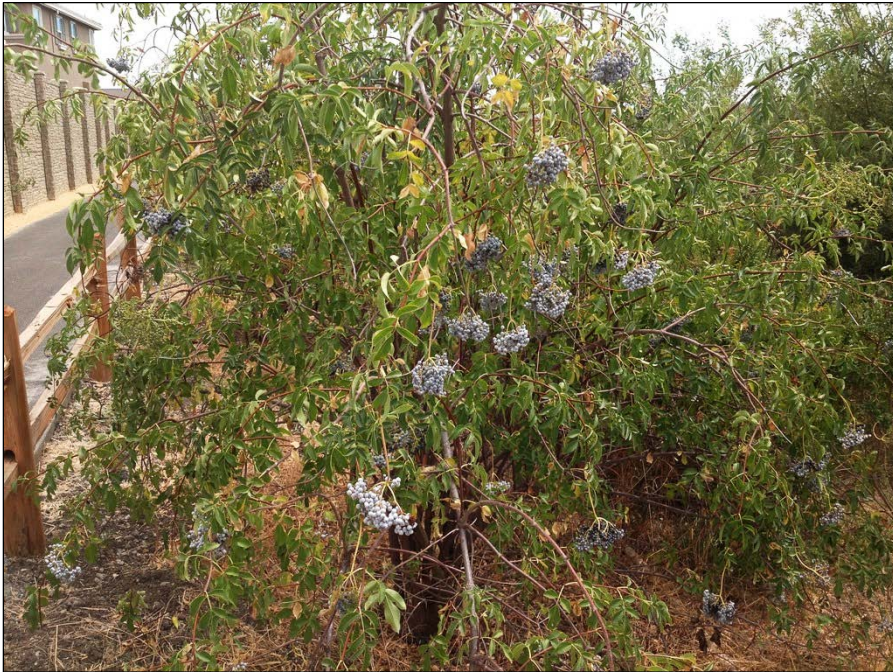
Despite ongoing drought conditions in the region, nearly every planted tree and shrub displayed good health and vigor (Photo 24; Tables 7 and 8). Moreover, a greater percentage of individuals were in good condition in Year 5 relative to previous years (Table 8). The overall average health and vigor of the woody plantings was 1.0 (good) in Year 5 (Table 7). The average health and vigor rating for each species was 1.0 (good). Table 8 lists the percentage of individuals that fall into the three general health and vigor categories by monitoring year. The percentage of individuals in good condition increased from 72.6% in Year 4 to 98.5% in Year 5. The percentage of individuals in fair condition decreased from 23.9% in Year 4 to 1.2% in Year 5. The percentage of individuals in poor condition decreased from 3.5% in Year 4 to 0.3% in Year 5.

Photo 24. Vigorous elderberry planting on the eastern creek bank slope (July 2015)

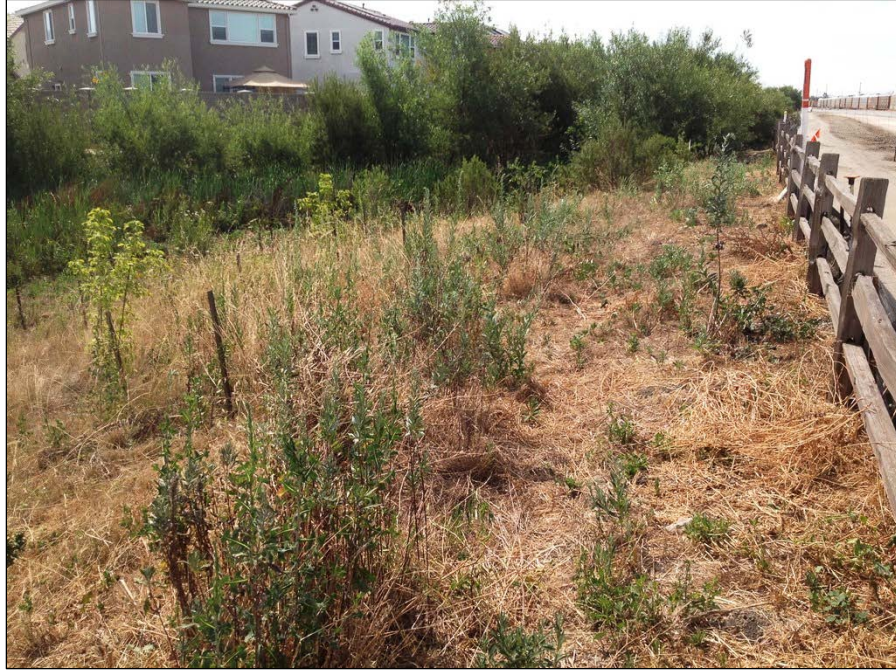
Photo 25. Mugwort natural recruitment on the western creek bank slope (July 2015)
