*Measure B*

**Consolidated Biological Mitigation  
Project**

**Year 11 Monitoring Report**  
*January to December 2014*

**Santa Clara Valley Transportation Authority**

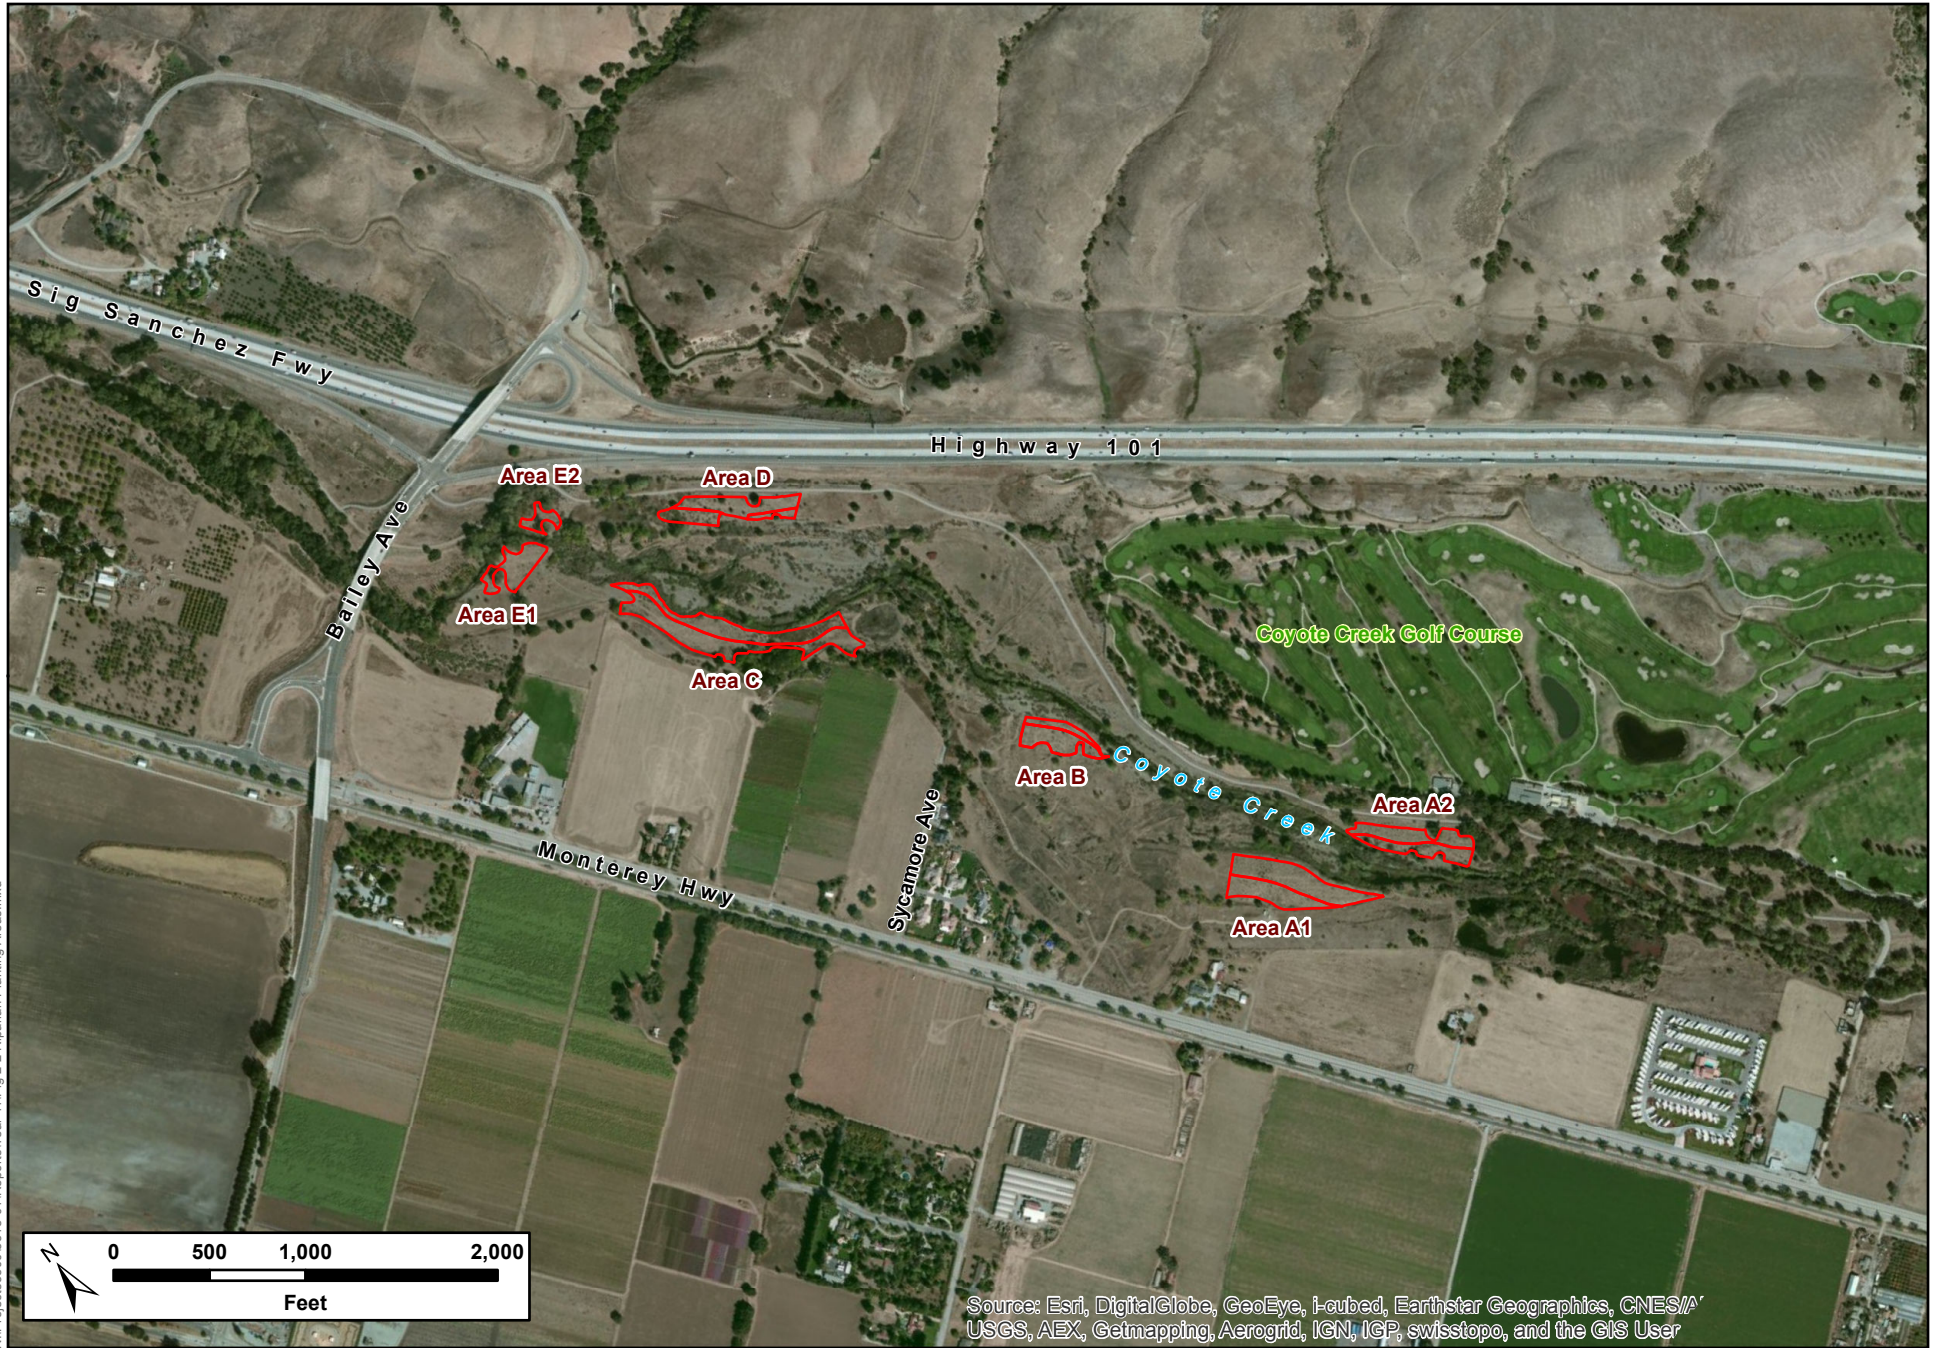
N:\Projects\3500\3518-01\Reports\Year 1\Fig 2-2 Riparian Planting Areas.mxd

At the end of Year 5 (2008), the Tenant Road riparian mitigation areas and the SRA mitigation areas at both sites were performing well and had met their success criteria; however, the Riverside Drive riparian mitigation areas fell short of their requirements. The CDFW and RWQCB were consulted to discuss these sites in detail and elicit feedback on a preferred adaptive management and monitoring approach. Formal meetings were held with representatives from these agencies on 11 December 2008 and 28 May 2009. As a result of these discussions, agency sign-off was requested for the Tenant Road riparian mitigation area and all SRA areas, and a remedial management approach was proposed for the Riverside Drive riparian mitigation areas (H. T. Harvey & Associates 2010a). The remedial measures for Riverside Drive were outlined in *a Year 5 Update and Permit Amendment Request memo* and included a reassessment of the target habitat, a significant replanting effort, a California sycamore pilot planting project, and revised monitoring methods and success criteria for riparian planting areas A-1, A-2, B, C, D, E-1, and E-2 (Figure 2-2) (H. T. Harvey & Associates 2009).
