**H. T. HARVEY & ASSOCIATES**  
**ECOLOGICAL CONSULTANTS**

**TASMAN WETLAND MITIGATION SITE  
YEAR-2 MONITORING REPORT**

24 June 2011

Project No. 2506-10

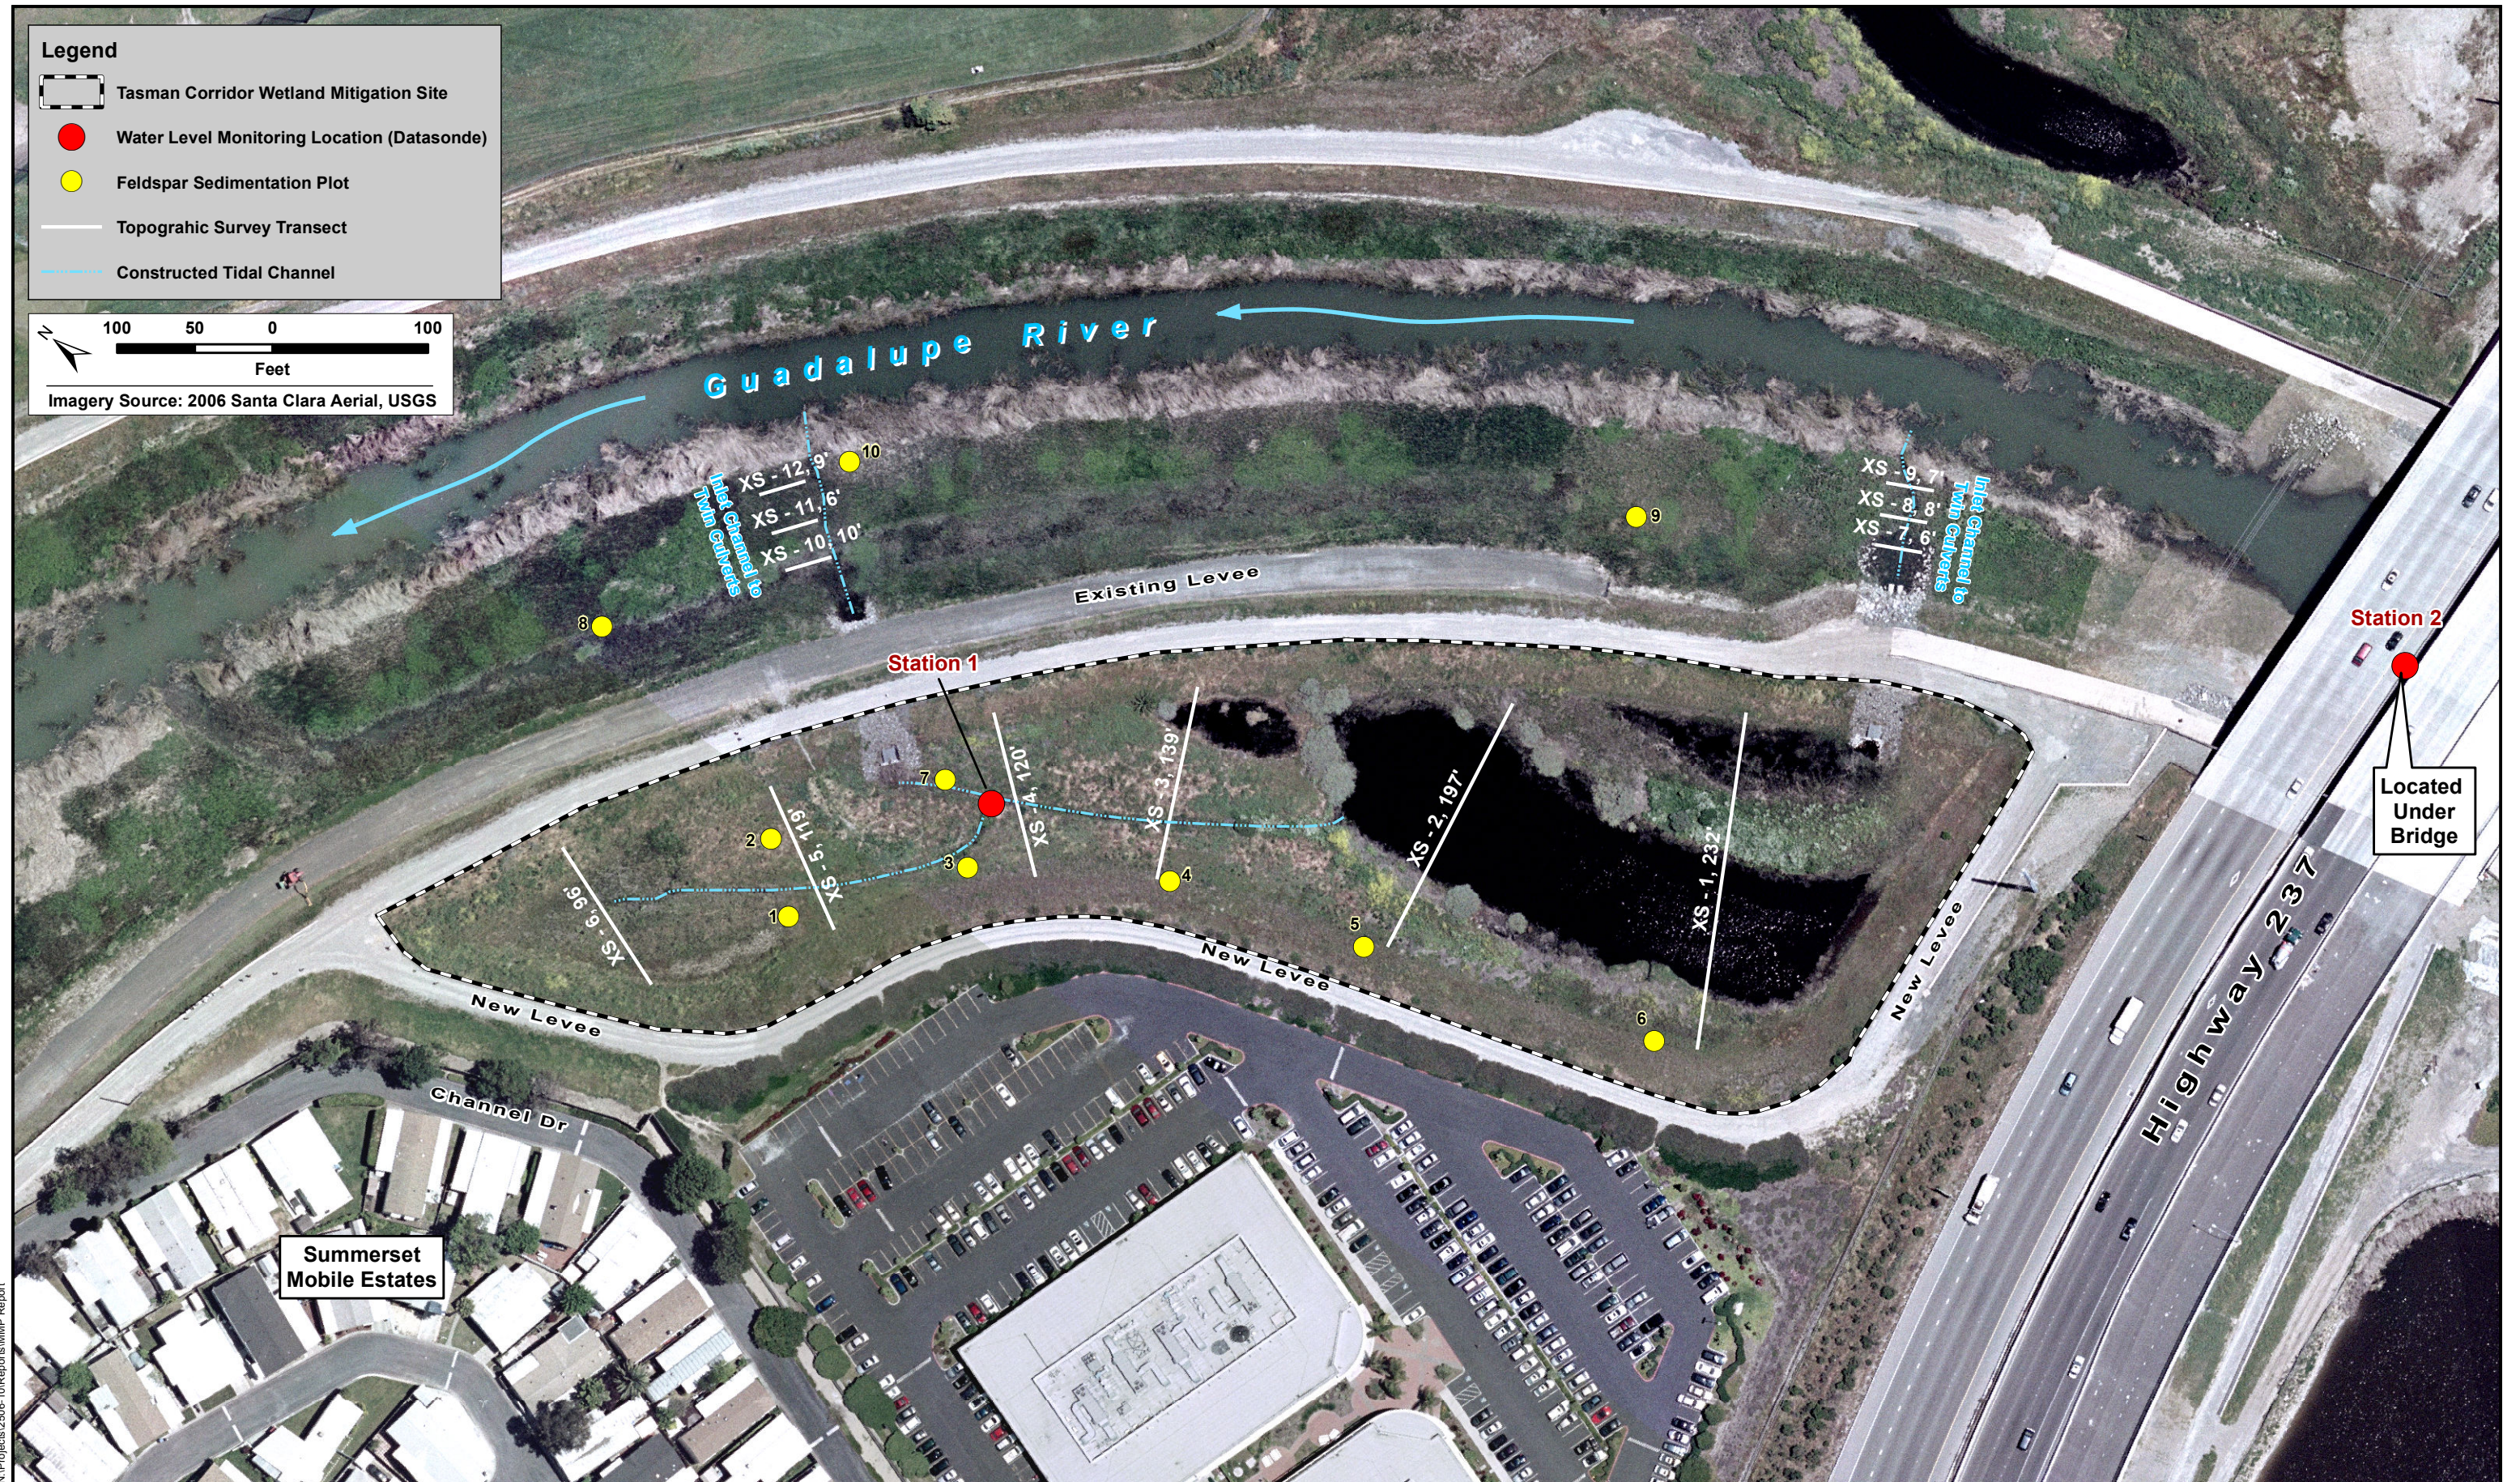
**Figure 3: Sedimentation and Water Level Monitoring Locations**  
 Tasman Corridor Wetland Mitigation Project - Year-1 Monitoring Report ( 2506-10)  
 June 2011

H. T. Harvey & Associates installed sedimentation monitoring plots at the mitigation site in 2009 (Figure 3). Feldspar marker horizon plots (0.25 square meters [m<sup>2</sup>]) were installed to measure short-term vertical accretion (Cahoon and Turner 1989; Ball 2005). On 2 September 2009, seven feldspar plots were established within the wetland mitigation site and three sites were established in the natural marsh adjacent to the Guadalupe River. These sites were added as an additional monitoring measure to determine whether differences in sedimentation patterns exist between the 2 marshes. Measurements were taken at these sites at 1, 2, 3, 9, and 12 months.

Within the mitigation site, the greatest sediment accumulation continued to occur in the vicinity of the northern/downstream inlet channel (i.e., feldspar plots 1, 2, 3, and 7); the least sediment accumulation is associated with plot 6 in the southwest corner of the site (Figure 3). The higher sedimentation in plots 1, 2, 3, and 7 generally correspond to slight increases in elevation in these areas as noted in the topographical surveys (Appendix B; Figures B1 – B12). Differences in the results between the feldspar marker horizon plot results and the topographic survey results can be attributed to the fact that there are fewer feldspar marker horizon plots, and that each of these plots measures sediment accumulation in a discrete location, whereas the topographic surveys measure elevation along a transect of considerable horizontal distance.

For the Guadalupe River plots, sediment accumulation was also greater in the vicinity of the northern inlet channel (i.e., plots 8 and 10) compared to plot 9, which is located near the southern inlet channel (Figure 3). These differences are not only similar to the geographic pattern of sediment accumulation observed within the mitigation site (i.e., greater near the northern inlet channel), but are suggestive of greater tidal flushing (and scouring) for the northern compared to the southern inlet channel.

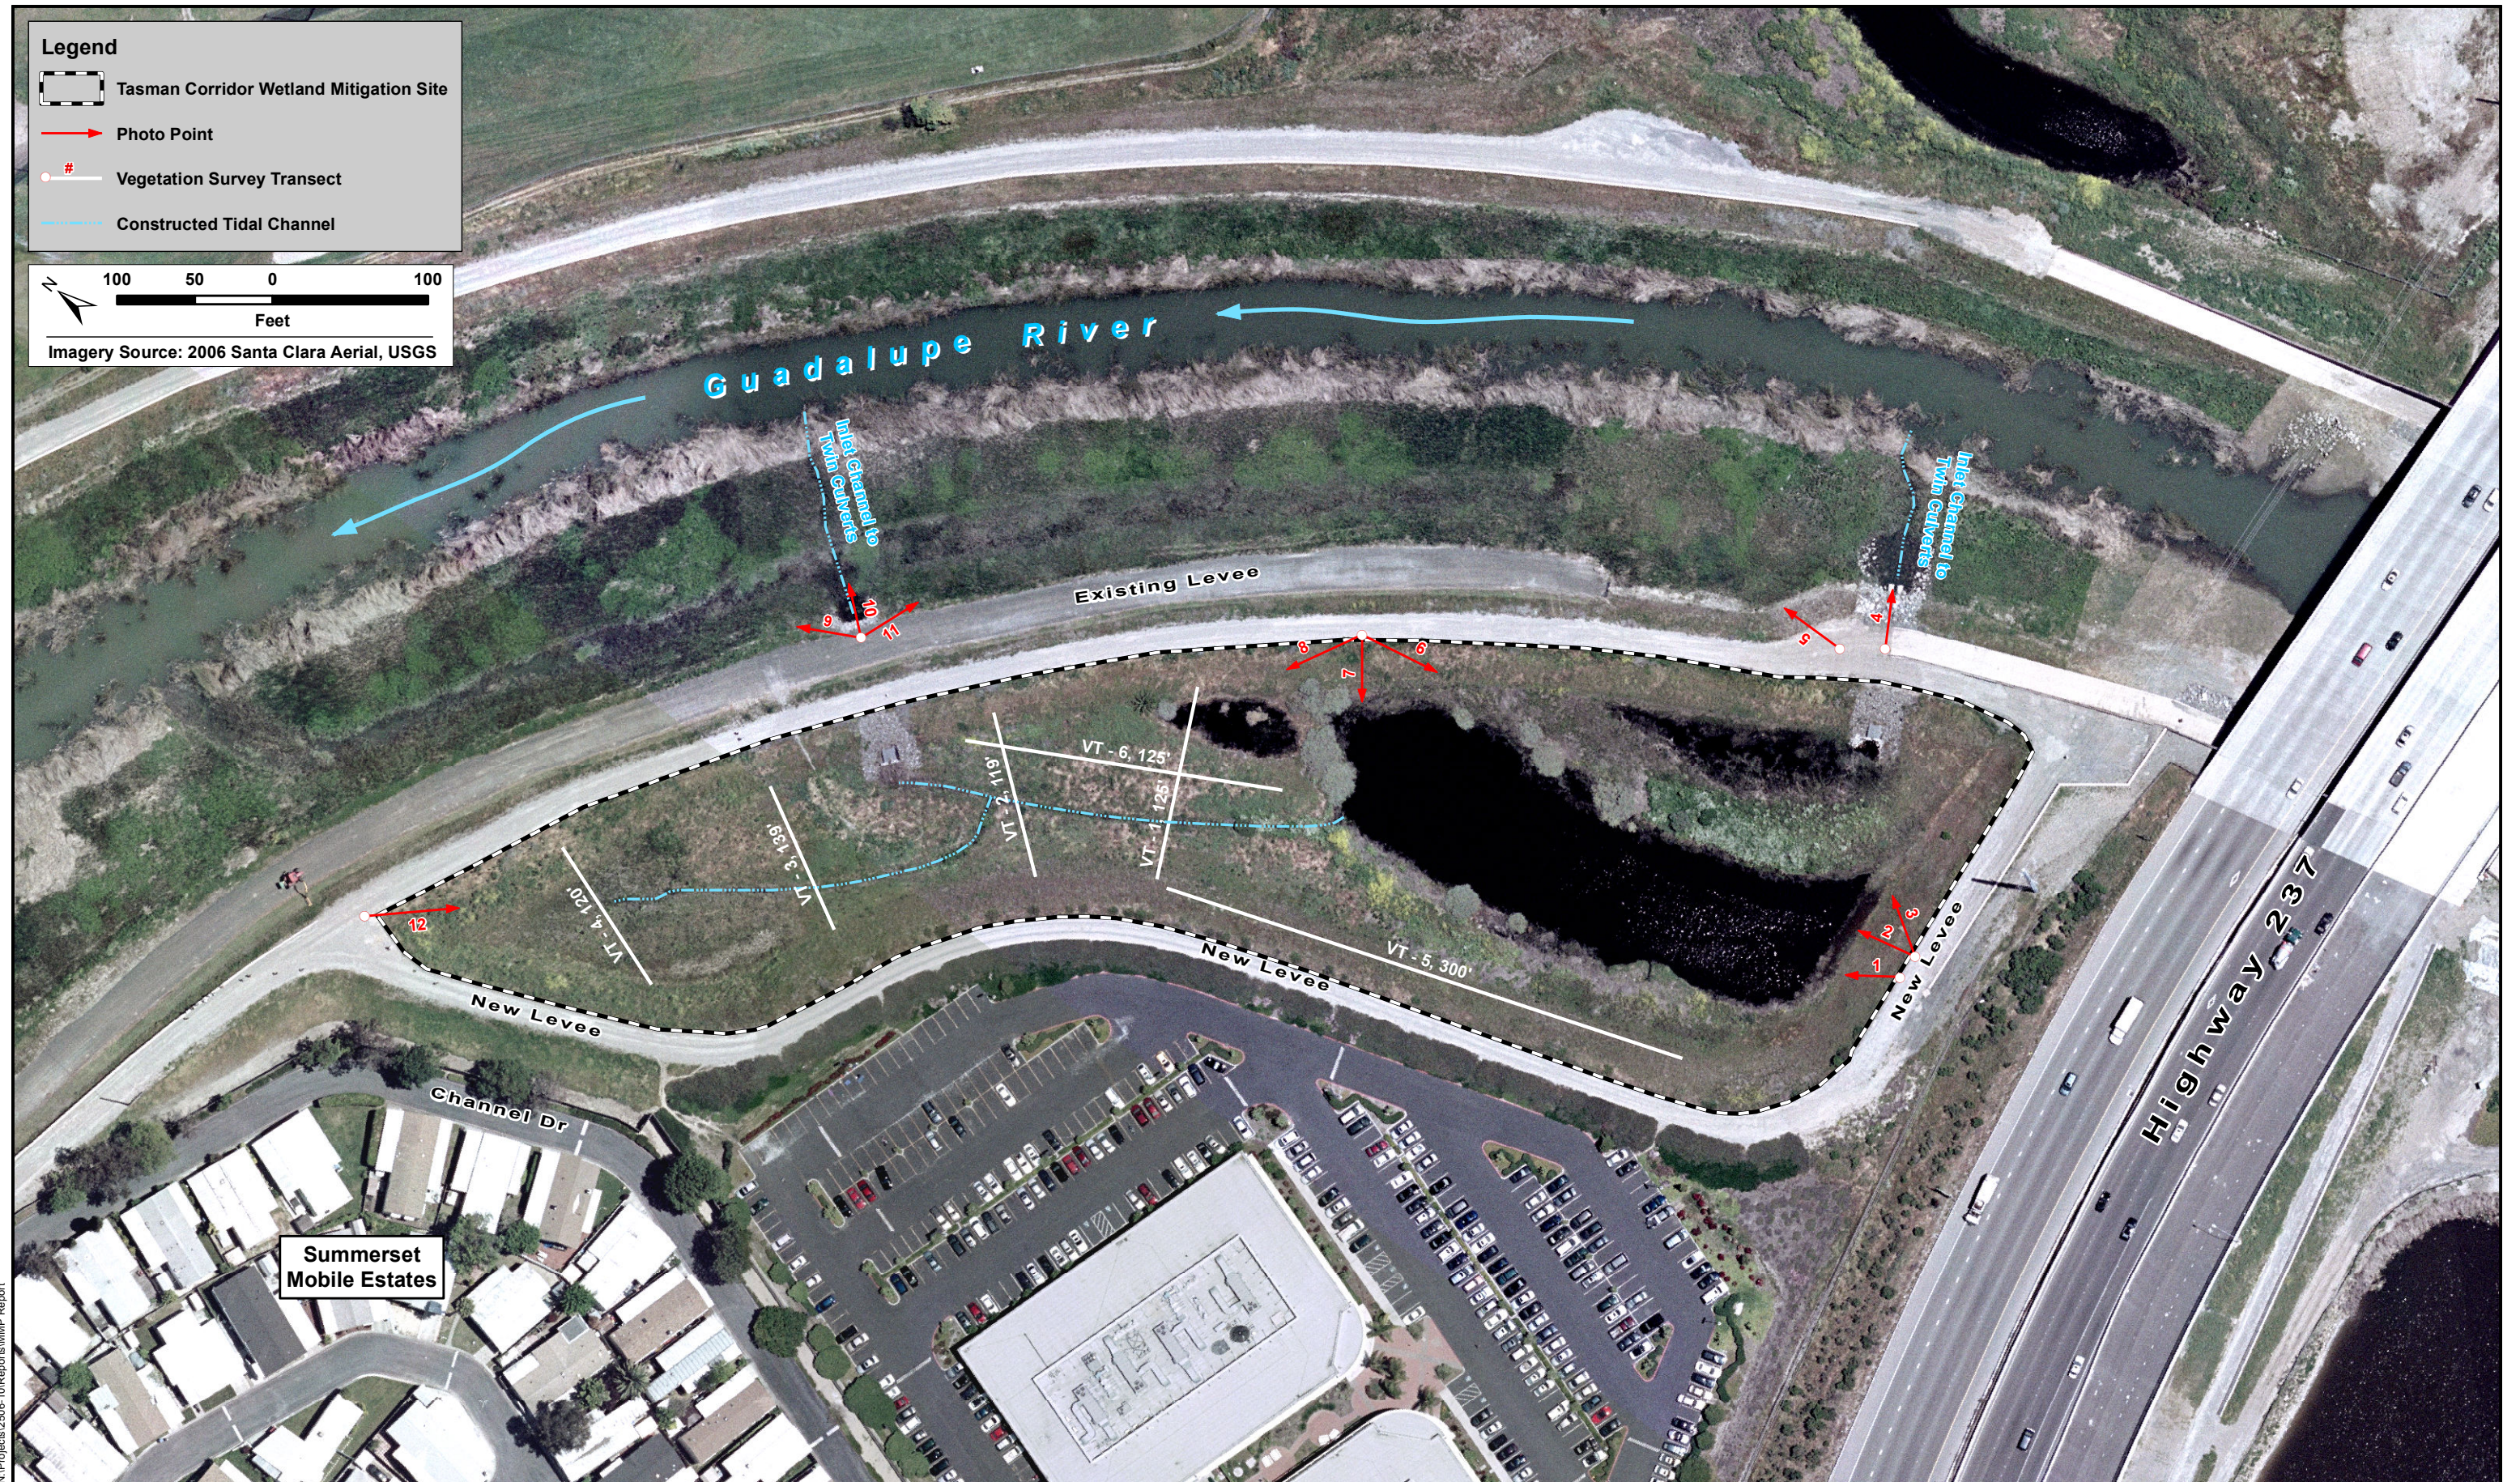
As in Year-1, one datasonde was installed at the interior of the mitigation site (Station 1), and the other near the adjacent Guadalupe River marsh under the State Route 237 bridge (Station 2) (Figure 3). These station locations were selected to compare water level fluctuations within the mitigation site to the Guadalupe River, and to discern the level of muting, if any, of the tidal amplitude by the site's culverts/inlet channels. The datasondes were installed using the same hardware and methodology described in the Year-1 Monitoring Report (H. T. Harvey & Associates 2010), and all elevation data were converted to NGVD 29 to compare to survey elevation data for the mitigation site and the Guadalupe River site.

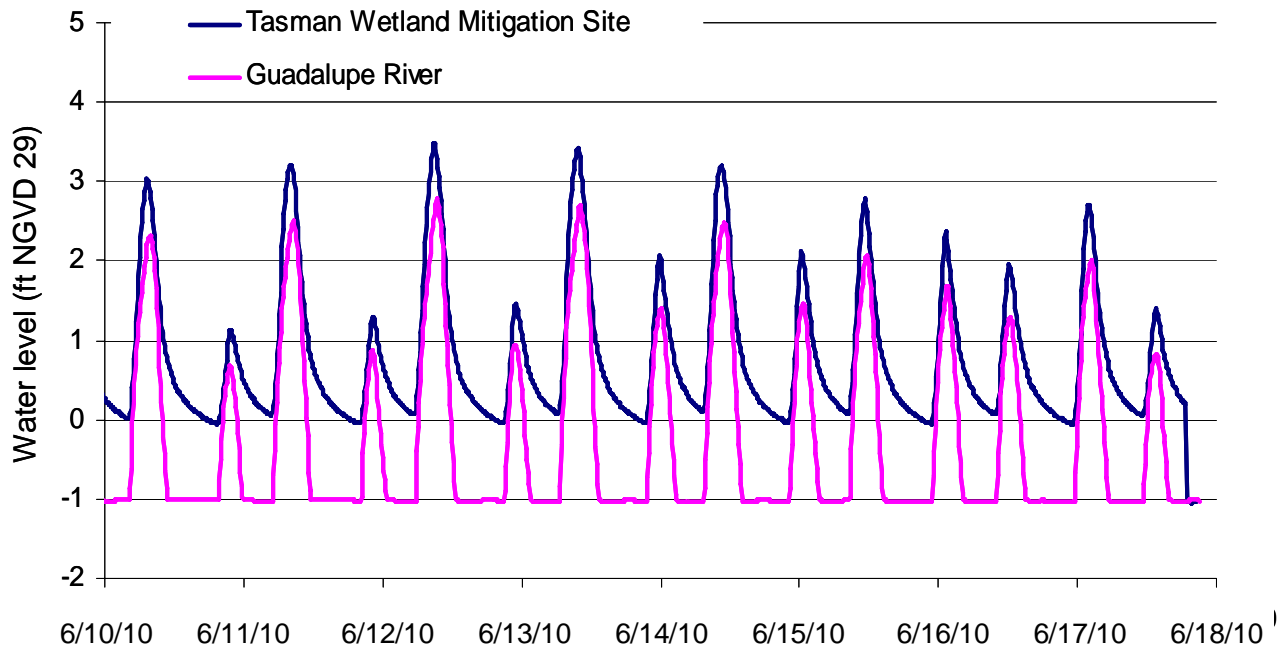
**Figure 5. Continuous Water Level Measurements (NGVD 29) - Comparison of the Tasman Wetland Mitigation and Guadalupe River (Reference) Sites.**

Water levels were calculated in NGVD29 based on the surveyed elevations. The results of water levels for both Station 1 (Tasman Wetland Mitigation Site) and Station 2 (Guadalupe River site) in NGVD29 are shown in Figure 5.

The 2010 water level results demonstrate that the mitigation site (Station 1) experiences daily tidal flushing via 2 high and 2 low tides each day. The results also show that the tidal range of the mitigation site differs from the Guadalupe River site (Station 2) (Figure 5). The tidal amplitude within the mitigation site is muted in comparison to the Guadalupe River site, particularly during the lower high tide event each day. The truncated lower tide water levels at the Guadalupe site indicate that the channel is fully drained at low tide, whereas channels within the wetland mitigation site do not fully drain at low tide (Appendix A; Photo A-14). However, Figure 5 indicates a higher water level in the Tasman site compared to the Guadalupe River site. This is unlikely, and the discrepancy is probably due to a survey error during the datasonde installation; the sediment in the channel where the datasonde is highly unconsolidated, making it difficult to accurately position the stadia rod to determine the channel bottom elevation.

The MMP's performance criterion specifies that tides within the mitigation site should only be slightly muted compared to tides on the Guadalupe River marsh plain. It also stipulates that high tide water surface elevation in the mitigation area should not deviate from that in the Guadalupe River by more than 0.5 ft (H. T. Harvey & Associates 1997). As is visible in Figure 5, the mitigation site has yet to achieve either performance criterion. The elevation at the lower end of the tidal range increased from approximately -0.5 ft in 2009 to approximately 0.0 ft in 2010. This increase is attributed to sediment accumulation in the channel where the datasonde was positioned (refer to Appendix B; Figures B-4 and B-5). As a result, the tidal signature continues to be muted, particularly at low tide. The criterion also states that the tidal elevations should not vary by more than 0.5 ft. In 2010, tidal elevations exceeded the 0.5 ft similarity criterion.
