**Blossom Hill Station
Arborist Report**

Project #4361-01

H. T. Harvey & Associates

February 19, 2020

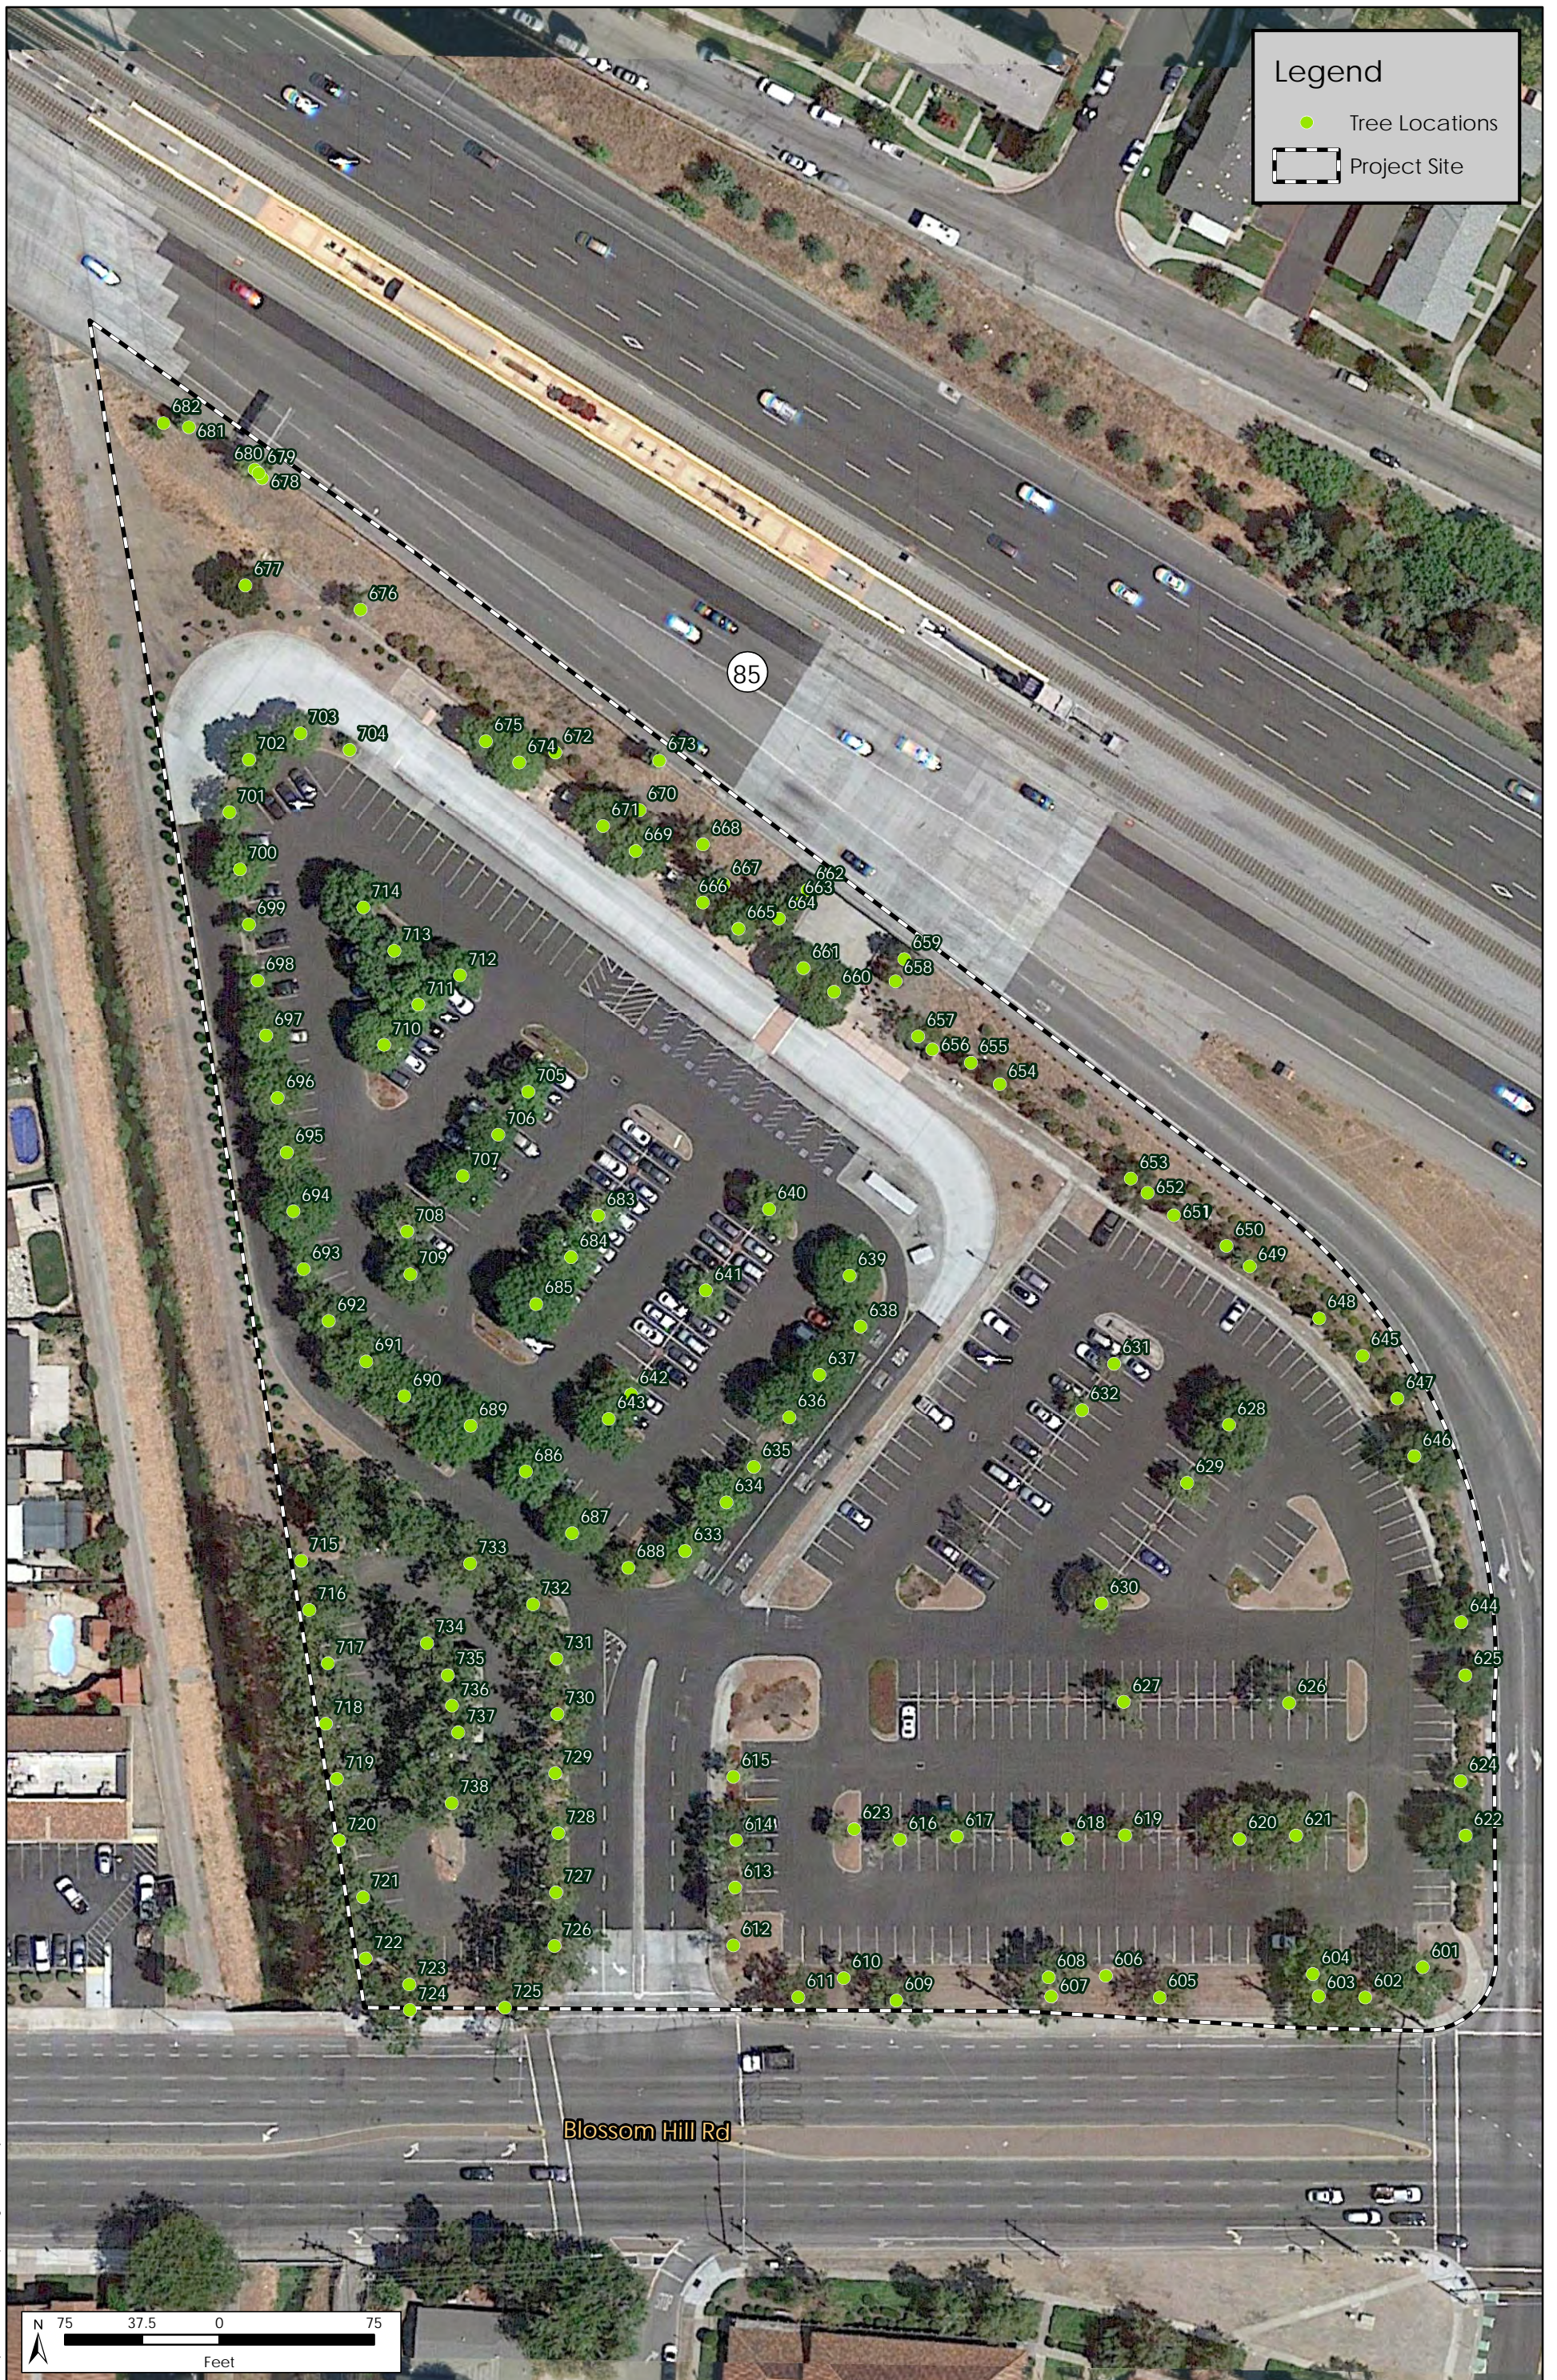
Figure 2. Locations of Existing Trees
Blossom Hill Station Arborist Report (4361-01)
February 2020

Eighty (80) trees (58%), including 30 of the 54 Chinese pistache trees, were in good condition, 45 trees (33%) were in fair condition, and 13 trees (9%) were in poor condition (Table 2). Health and vigor scores and condition ratings of each tree are presented in Appendix C. Most trees in poor and fair condition were evergreen pear (*Pyrus kawakamii*) and exhibited canopy dieback such as shown in Photo 2 in Appendix D.
