**Wrigley Creek Improvement Project
Milpitas, California
Year 5 (2015) Monitoring Report**

Project #2995-04

September 2015

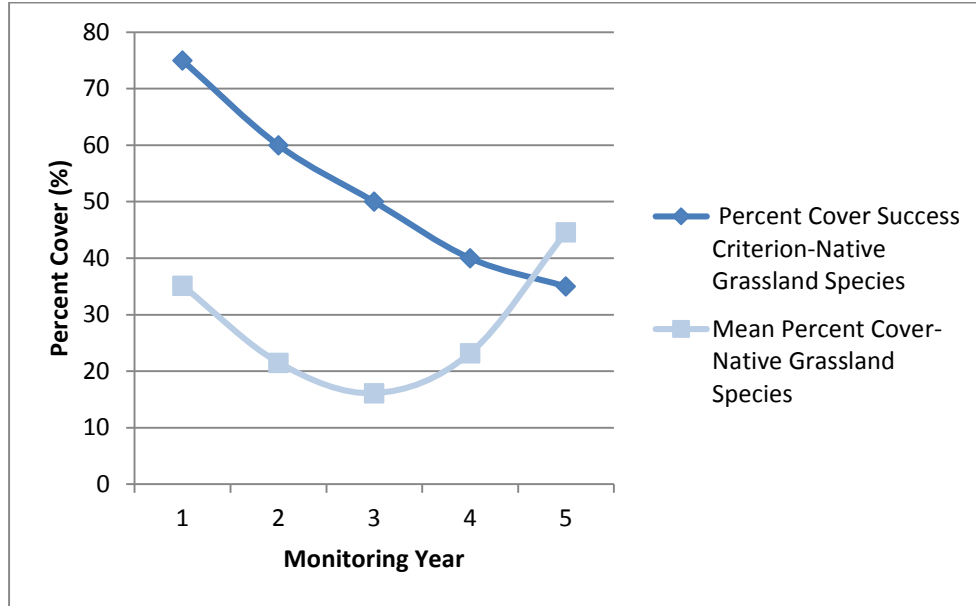
Figure 3. Mean Percent Cover of Native Grassland Species Compared to Success Criterion.

The average percent cover of native grassland species in Year 5 is 44.6% (Table 5, Figure 3). The percent cover of native grassland species on the site is substantially higher than is typically found in local grassland habitats. In addition to the populations encountered along the sampling transects, dense stands of native purple needlegrass (*Stipa pulchra*) were observed on the upper slopes of the west creek bank and dense stands of native meadow barley (*Hordeum brachyantherum*) were observed throughout the floodplain (Photos 21 and 22). The Year 5 percent cover of native grassland species exceeds the Year 5 success criterion of 35%.

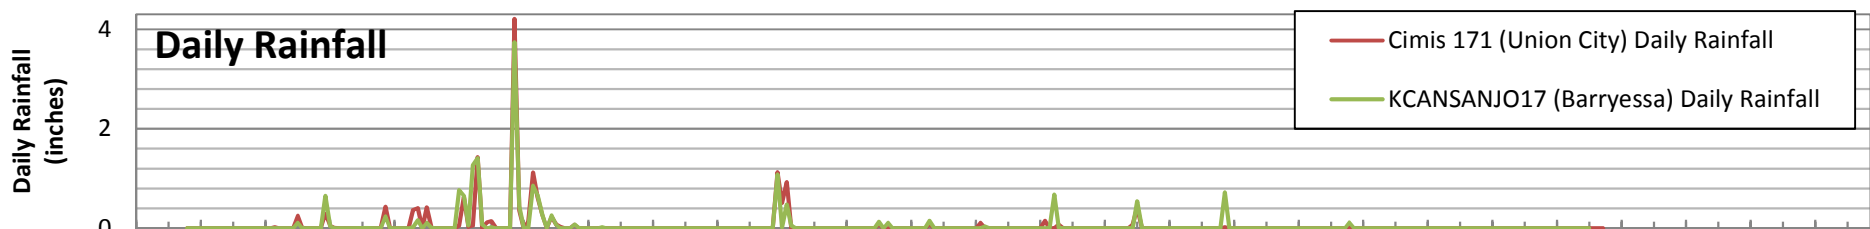
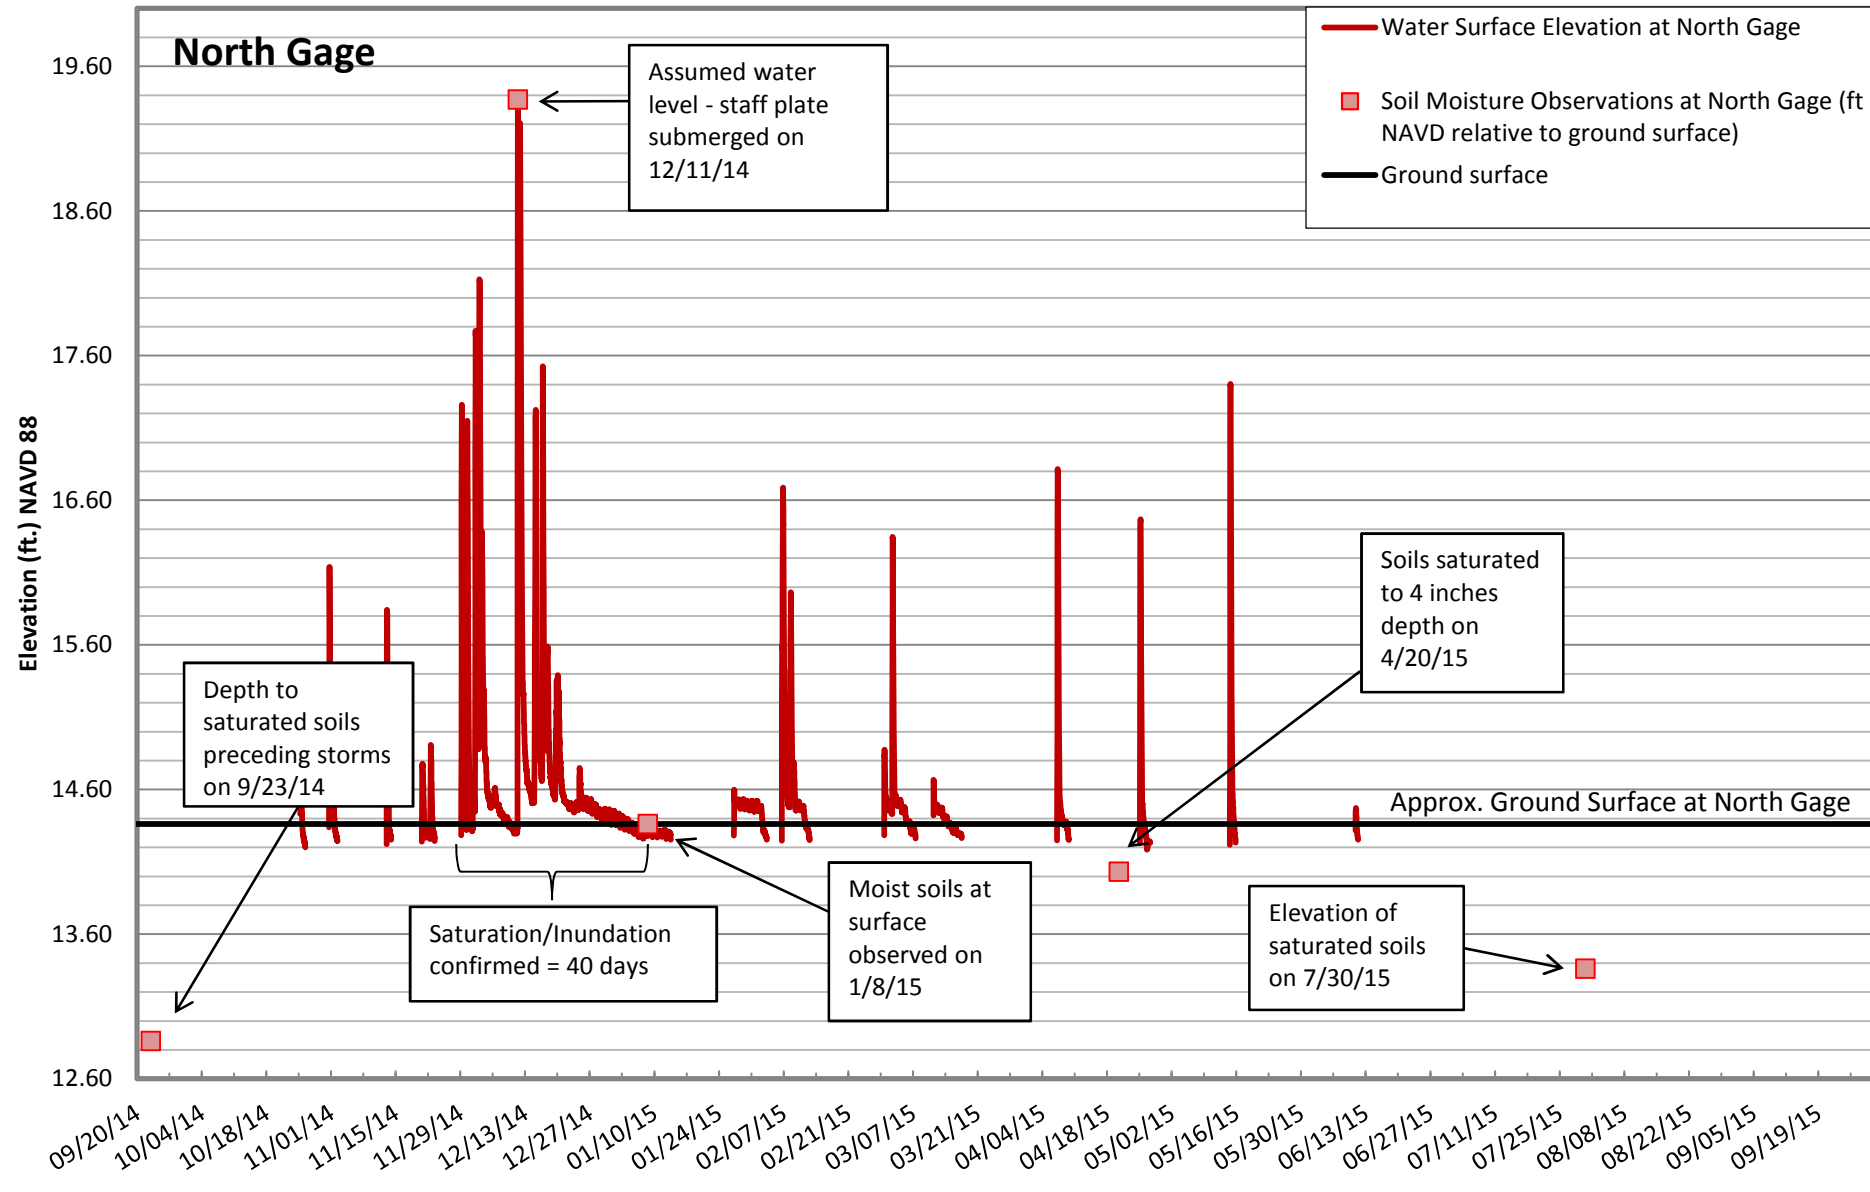
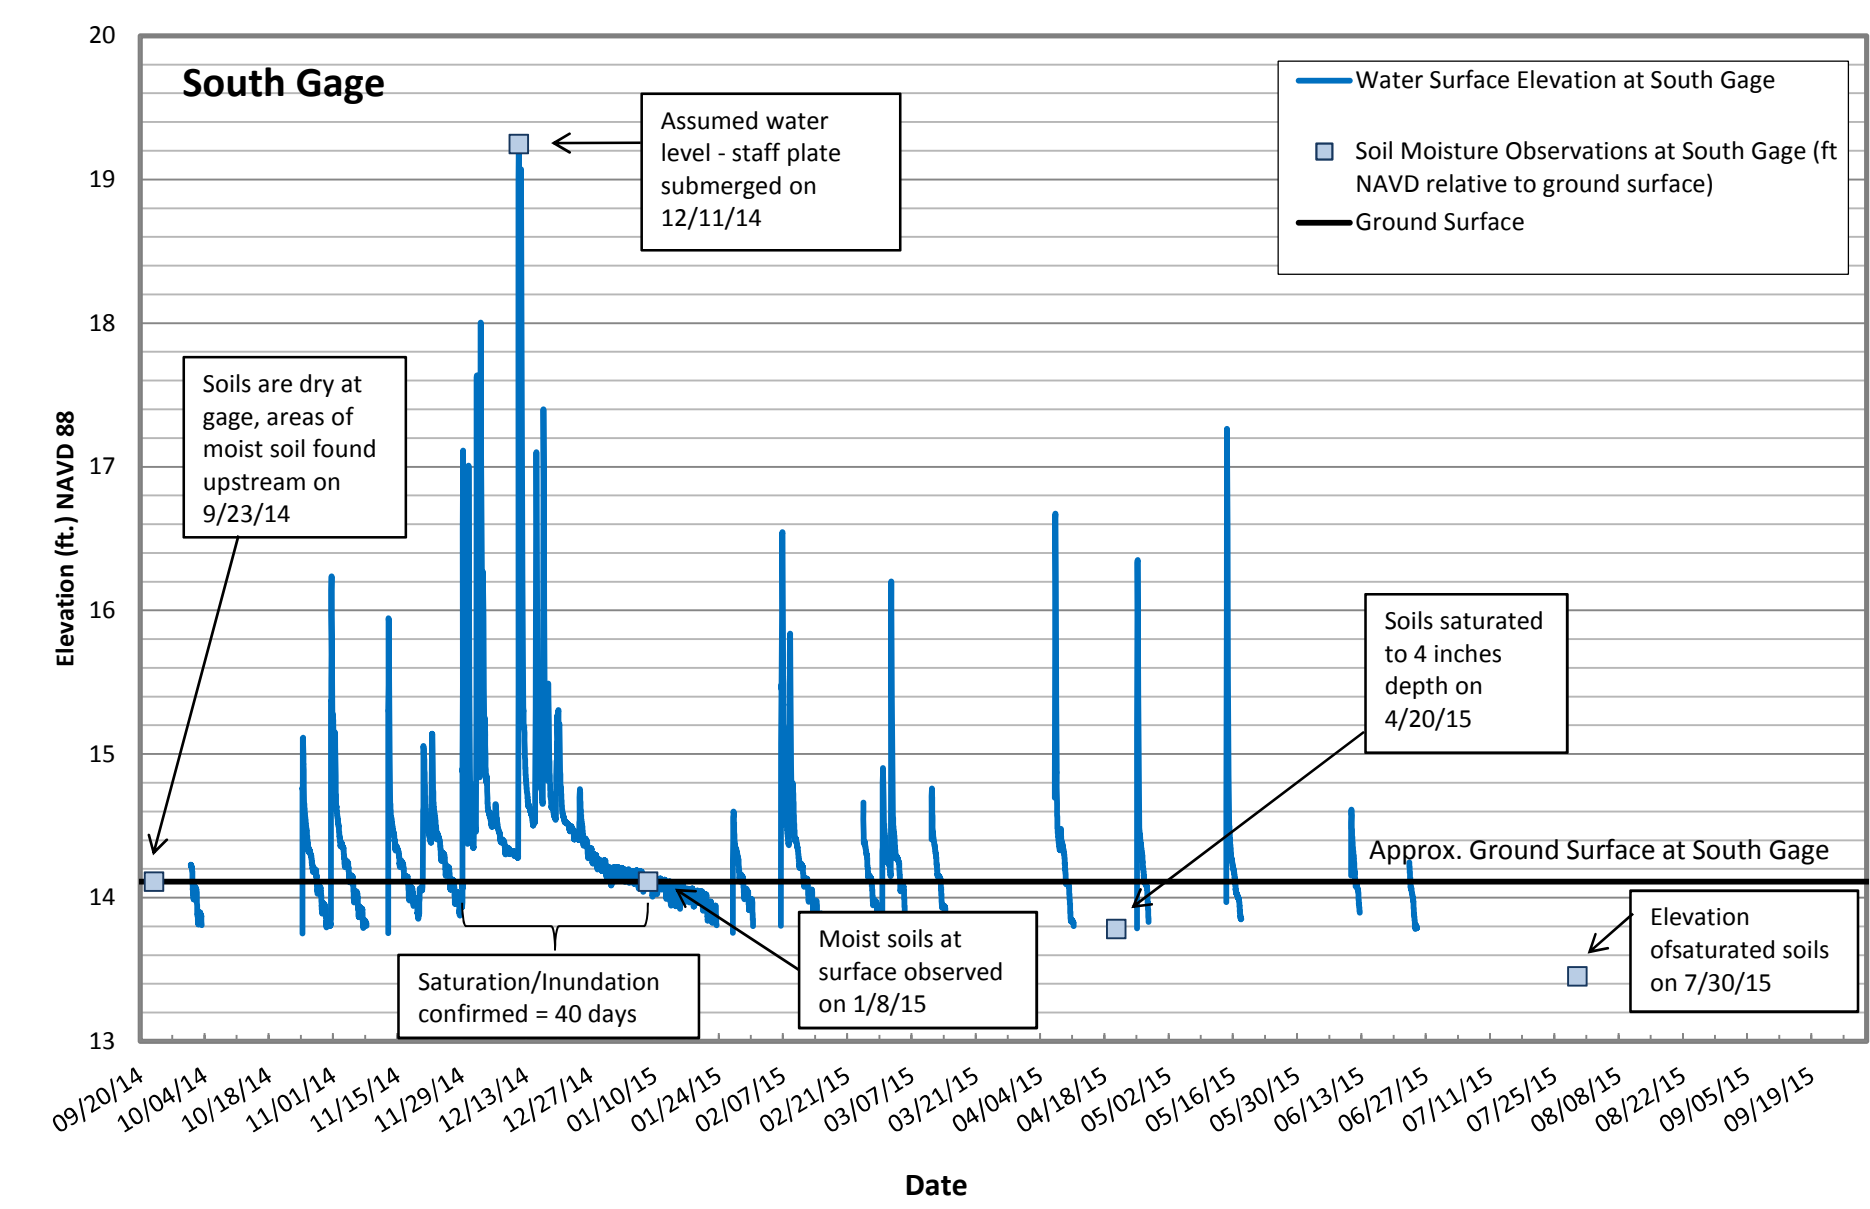
Throughout the wet season, there were approximately 59 days (discontinuous) during which the north gage site was inundated (**Figure 4**). The longest continuous period of inundation was about 24 days, from December 11, 2014 to January 3, 2015. The stage record and field observations show that between November 29, 2014, when storms inundated the site, and January 8, 2015, when moist soils were observed in the field, soils near the gage were either inundated or saturated at a depth of approximately 2 inches, a period of continuous inundation/saturation lasting 40 days. **Figure 5** shows site photos from the January 8 field visit.

The south gage is located on a section of floodplain that ponds during and after storm events, therefore this site is inundated for a longer duration. According to the stage record (**Figure 4**) there were approximately 78 (discontinuous) during which the south gage site was inundated. The longest period of continuous ponding/inundation lasted 32 days, from November 29, 2014 to January 3, 2015. As at the north gage site, the stage record and field observations show that between November 29, 2014, when storms inundated the site, and January 8, 2015, on which moist soils were observed in the field, soils near the gage were either inundated or saturated at a depth of approximately 2 inches, a period of continuous inundation/saturation lasting 40 days. **Figure 6** shows site photos from the January 8 field visit.
